Technical Service Bulletin

91 Audi Smartphone Interface (ASI): Apple CarPlay or Android Auto display screen intermittently goes blank in FPK

91 20 96 2060264/2 August 21, 2020. Supersedes Technical Service Bulletin Group 91 number 20-88 dated July 22, 2020 for reasons listed below.

Model(s)	Year	VIN Range	Vehicle-Specific Equipment
R8, TT, and TTRS	2018 - 2020	All	Not Applicable

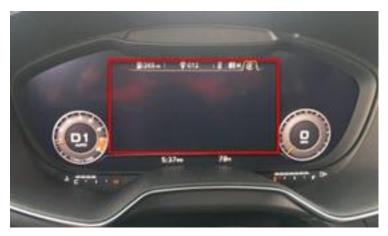
- The FPK (Free-Programmable Kombi/Cluster) screen goes blank intermittently when viewing the Audi Smartphone Interface (ASI) screen (Figure 1).
- This can occur while using Apple CarPlay or Android Auto.

Figure 1. FPK screen is blank.

This condition is caused by an MMI software configuration issue. Model Year 2019-2020 vehicles can have this issue with the factory-installed MMI software. Additionally, Model Year 2018 vehicles that received a recent MMI software update could also experience this issue. It's important to note that the issue is intermittent and does not

- 1. Follow all instructions in TSB 2047576: 91 MIB2 High Navigation Software Update Instructions (PR Code 7UG).
- 2. Update the infotainment system using the SVM action code and SD-Card as listed in the table below, if necessary:
