### **Technical Tip**

Transaction No: 2053976/3

27-19-01TT - Start/Stop System No Operation, May Also Occur After Battery Replacement

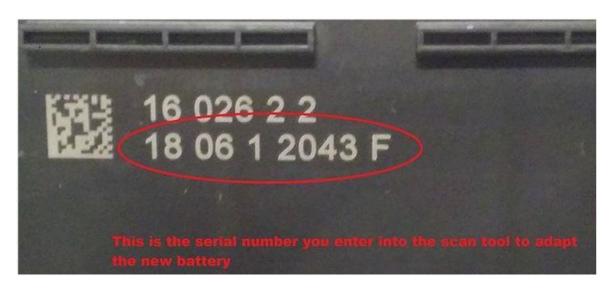
Another issue that may disable the Start/Stop function is when the battery or Battery Monitoring Control Module - J367has been replaced.

If the vehicle battery or Battery Monitoring Control Module - J367- has been replaced, they must be adapted to the vehicle. Failure to do so will compromise the operation of the charging system and may lead to premature battery failure and DTC's.

The test plan can be found in AW19 Gateway > GF > adapt battery, see figure 1 for additional information.

- Go to the test plan tab.
- Go to select self-test.
- Go to Magnifying glass.
- Search the word Battery or Battery Monitoring Control Module J367 (depending on what was replaced).
- Attach the test plan.
- Perform the test plan you attached, see figure 1 for additional information.
