## Passport Solar Prep Wiring

**Models Included:** 2020 Passport: 199ML, 239ML, 240BH, 267BH, 3400QD

**Serial Number Range:** MK410012 - MK410098

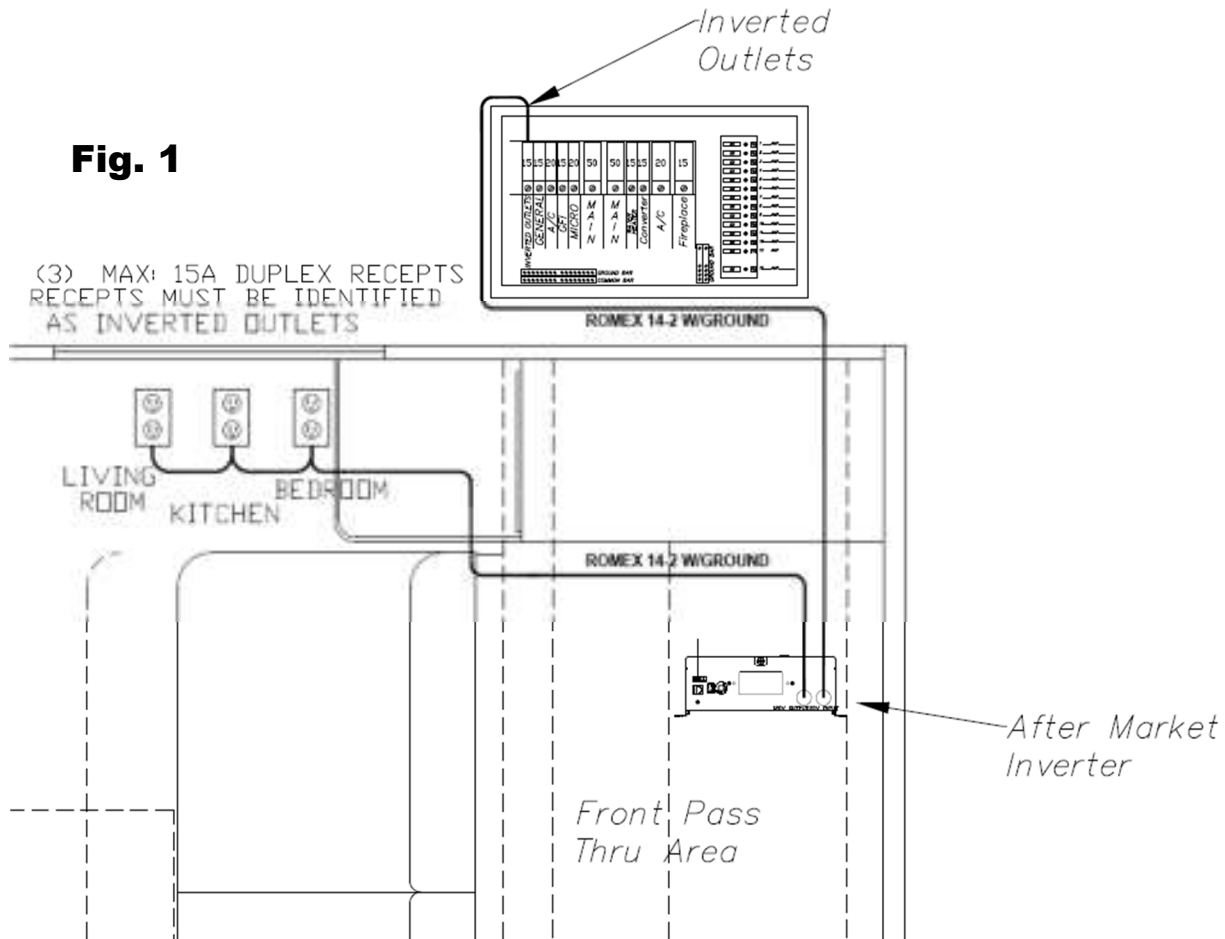
It has been determined the vehicles in this KSB population may have been manufactured without the 14-2 Romex inverter wire from the bedroom receptacle to the inverter prep in the front pass through compartment. Only units that are being set up with an inverter will require this repair, otherwise the unit works as designed.

Install a 14-2 Romex wire to the power center wire and run it through the front pass through compartment to the input side of the inverter. Also install a 14-2 Romex wire from the output side of the inverter back to a new 15 amp receptacle in the previously installed 1-gang electrical box to complete the circuit. See Figure 1.
