# TECHNICAL SERVICE BULLETIN

Technical Service Bulletin: 400-1207

Forest River is alerting you to an issue involving certain 2020 – 2021 – Soft Side Truck Camper Recreational Vehicles. Please see the information below, which describes the issue and provides you with details on the steps you should take to have your vehicle repaired.

# TECHNICAL SERVICE BULLETIN 400-1207 REMEDY INSTRUCTIONS

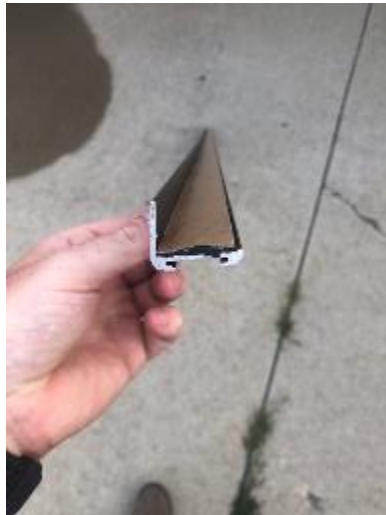
FIGURE 1

The front roof membrane may not be adequately secured.

STEP 1: APPLY BUTYL TAPE TO THE LONG LEG CORNER EXTRUSION (FIGURE 1);
