TECHNICAL SERVICE BULLETIN

Technical Service Bulletin: 67A-1222

Forest River is alerting you to an issue involving certain 2021 Salem Travel Trailer and 2021 Wildwood Travel Trailer Recreational Vehicles. Please see the information below, which describes the issue and provides you with details on the steps you should take to have your vehicle repaired.

TECHNICAL SERVICE BULLETIN 67A-1222 REMEDY INSTRUCTIONS

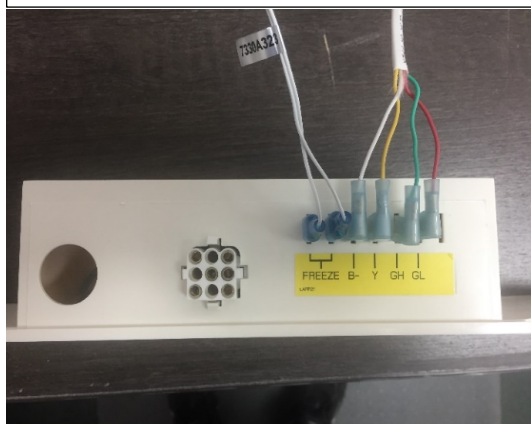
Correct Wiring – (Left to Right)
 Freeze Sensor – White / White
 B -> White
 Y -> Yellow
 GH -> Green
 GL -> Red

STEP 8: Remove and reconnect the connections as shown in Fig. 7

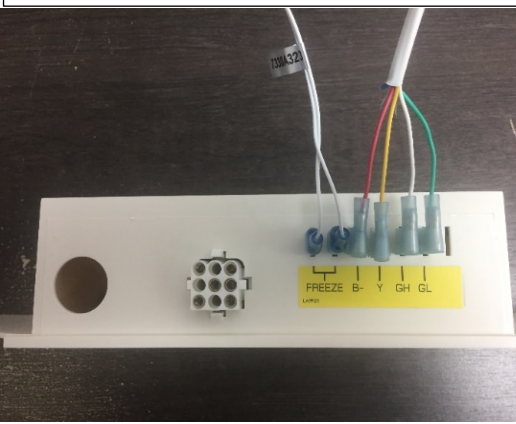
Concern: The thermostat is wired incorrectly at the air conditioning control box located at the ceiling assembly. This condition will cause the fan to not run when using the low setting only. However, the compressor will still run.

Incorrect Wiring – (Left to Right)
 Freeze Sensor – White / White
 B -> Red
 Y -> Yellow
 GH -> White
 GL -> Green

STEP 7: Compare wire connections at air conditioner control board; see incorrect and correct illustration photos on Fig 7 & 8. If the wiring is like fig. 7 the wiring is correct. Proceed to Step 9. If the wiring is like Fig. 8 proceed to Step 8
