Service Bulletin

Bulletin No.: 18-NA-210

Subject: High Pitch Whine Noise Coming from Front Instrument Panel (IP) Speakers

Brand:	Model:	Model Year:		VIN:		Engine:	Transmission:
		from	to	from	to		
Chevrolet	Equinox	2018	2020	—	—	—	—
GMC	Terrain

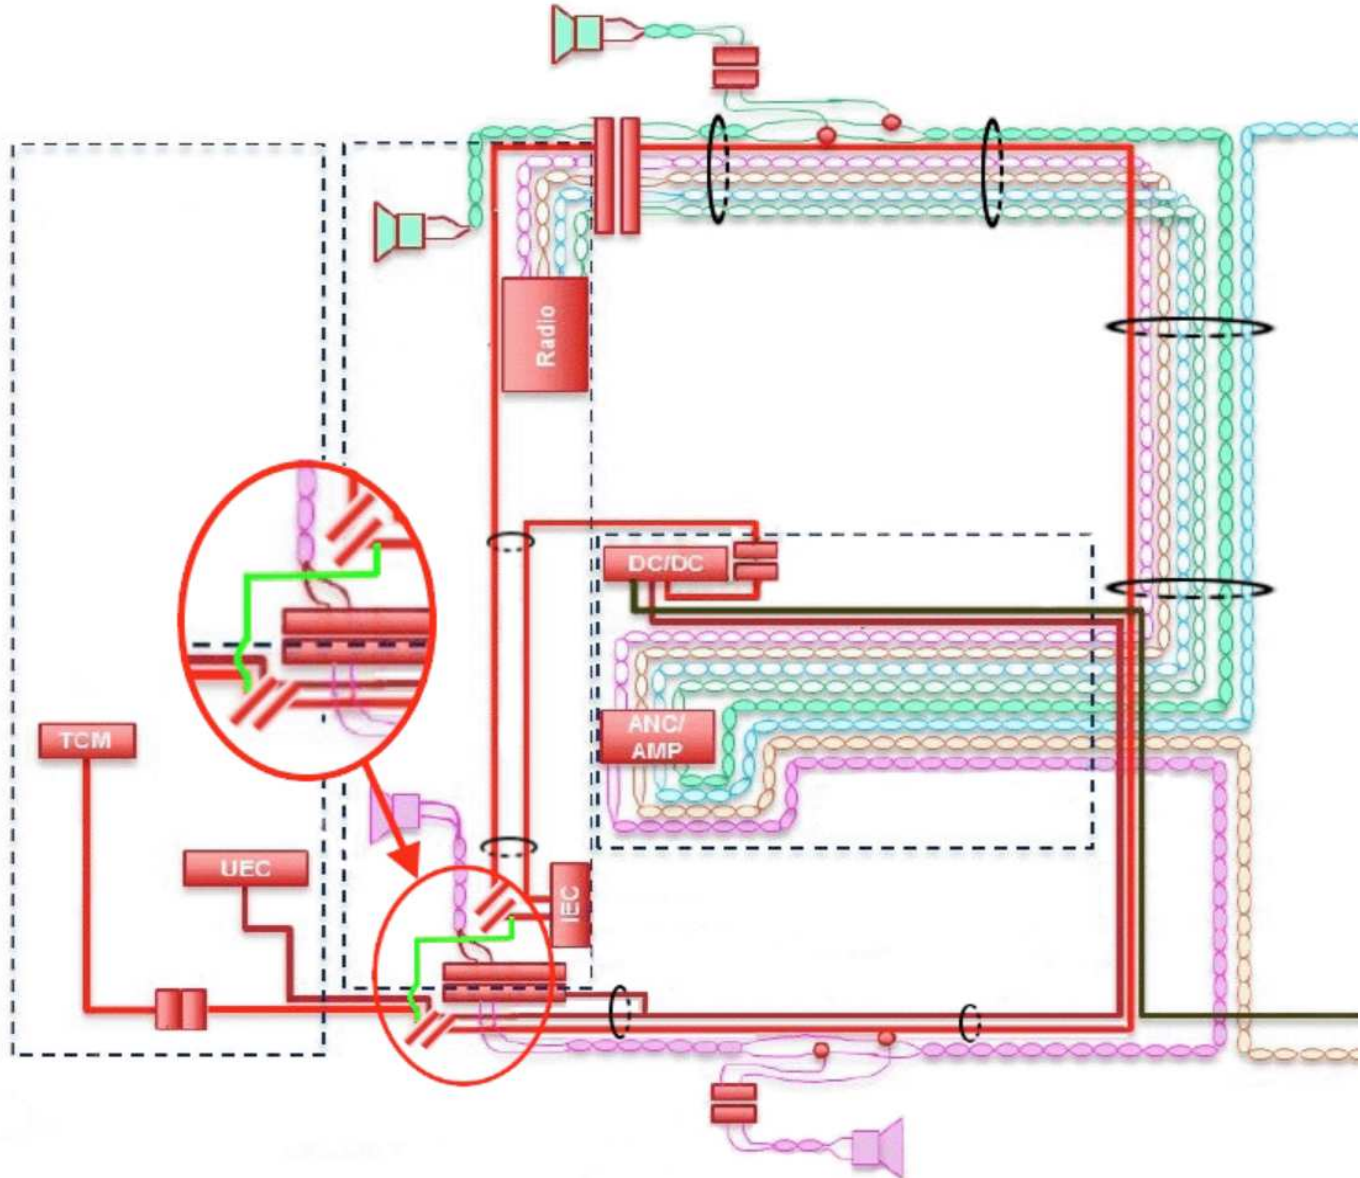
5112945

Important: Performing this repair will eliminate the 2173 circuit wire from the IP wiring harness and bypass it directly to the body side harness, as shown in green in the schematic above.
