Service Bulletin

Bulletin No.: 19-NA-068

Subject: Malfunction Indicator Lamp (MIL) Illuminated, Intermittent Service Messages, Gauges May Be Erratic - DTCs U0073, U0121, U0100 and/or U0101 Set, G103 Inspection

Brand:	Model:	Model Year:		VIN:		Engine:	Transmission:
		from	to	from	to		
Chevrolet	Trax	2015	2020	—	—	All	All

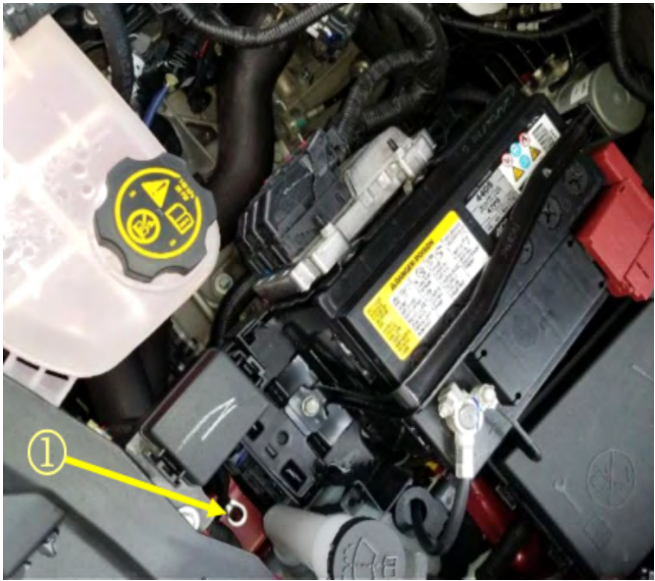
<p style="text-align: right;">5300153</p>

The cause of the condition may be a poor ground connection at G103 (1), located at the left front frame rail in front of the battery.

Perform inspection on ground G103; clean and/or remove paint from the grounds contact points and torque fastener to specification.
