# Service Bulletin

Bulletin No.: 19-NA-255

**Subject:** Wax Coating on Frame Peeling, Metal Shows Corrosion/Rusting (U.S. and Canada Only)

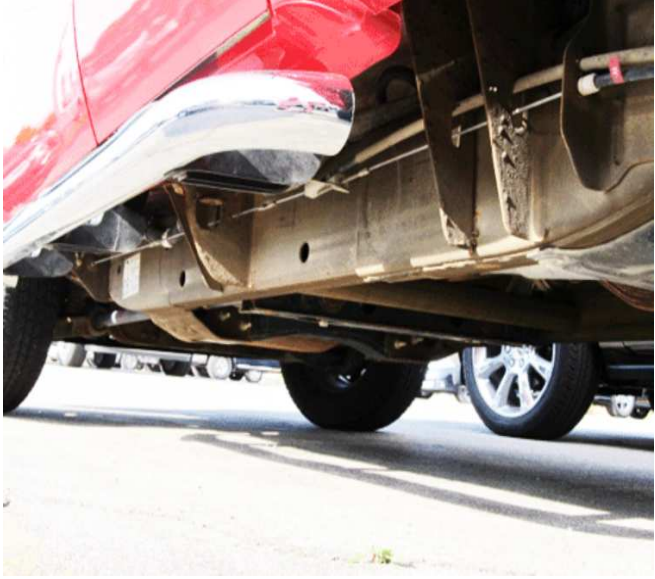
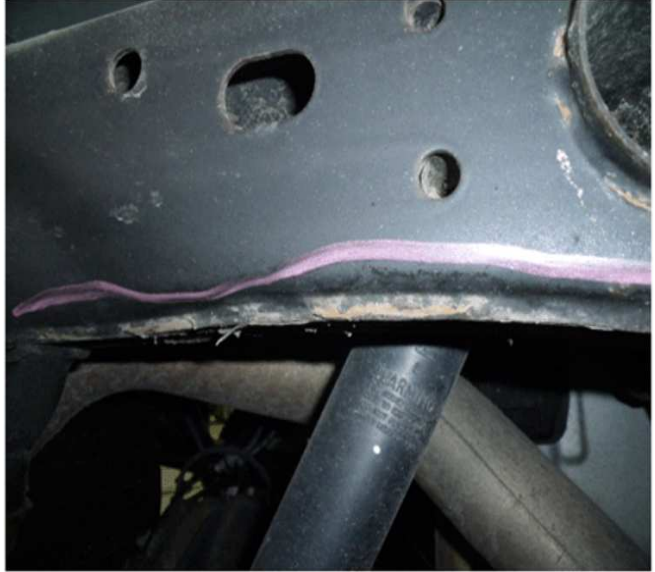
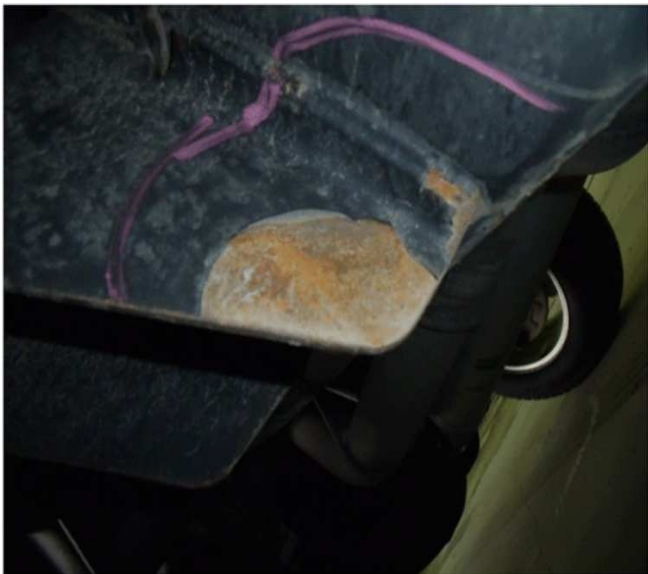
<b>Involved Region or Country</b>	North America, Europe, Middle East, Israel, Palestine, Chile, Columbia, Ecuador, Paraguay, Peru, Uruguay, Japan, S Korea, China, Taiwan, Thailand, Africa and Egypt.
<b>Additional Options (RPOs)</b>	
<b>Condition</b>	<p>Some customers may comment that areas of the frame wax coating are peeling off and rust/corrosion is visible on the metal in these areas. Several examples of this condition are shown in each group of graphics below.</p> <p><b>Truck Example Photos</b></p>

<p><b>Cause</b></p>	<p>The cause of this condition may be that the frame supplier may not have properly prepped the metal before the wax coating was applied.</p>
<p><b>Correction</b></p>	<p><b>Note:</b> A combination of specialized metal coating products manufactured by Lloyds and Daubert have been found to be the most suitable products to provide corrosion control and protection to address this type of repair. Our recommendation is to prep the metal surface using *Lloyd's Pure Prep™ Metal Surface Preparation P/N 25418, then topcoat with both *Lloyds Kryptonite Metal Treatment P/N 36502 Life Long Rust Protection and *Daubert Non-Rust® P/N X-121B One Coat Rust Preventative Coating. It is strongly recommended they be applied according to the manufacturer's procedures.</p> <p>*We believe this source and their products to be reliable. There may be additional manufacturers of such products/materials. General Motors does not endorse, indicate any preference for, or assume any responsibility for the products or material from this firm or for any such items that may be available from other sources.</p> <p>Prep the frame and apply the Lloyds and Daubert coatings following the steps in the Service Procedure below:</p>

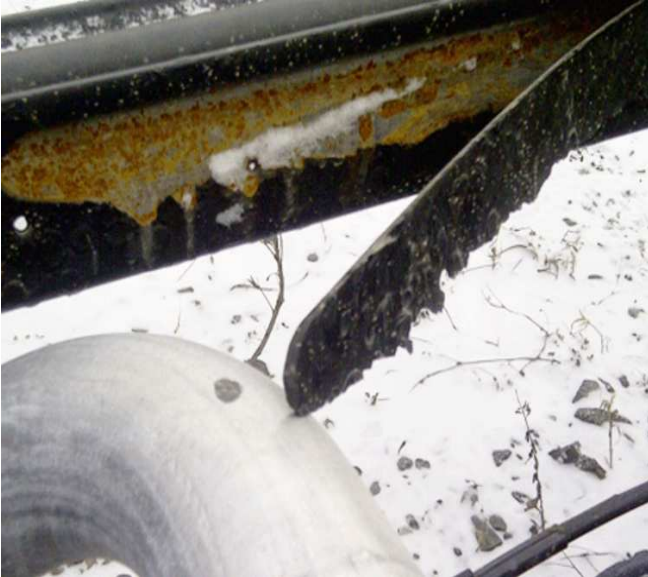
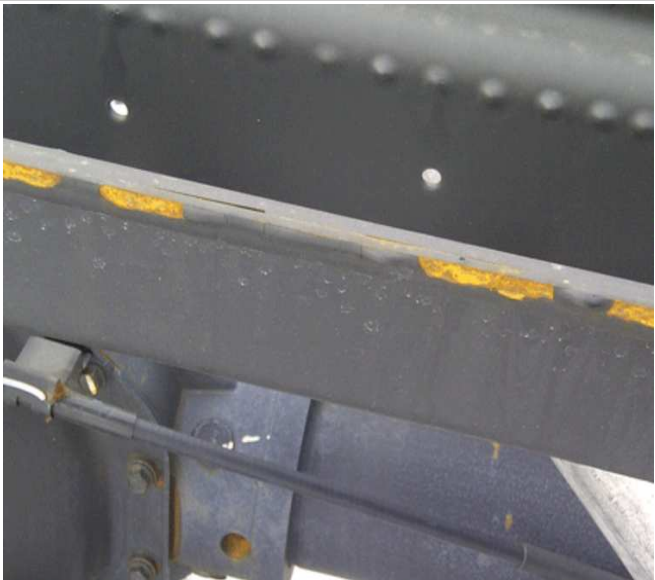
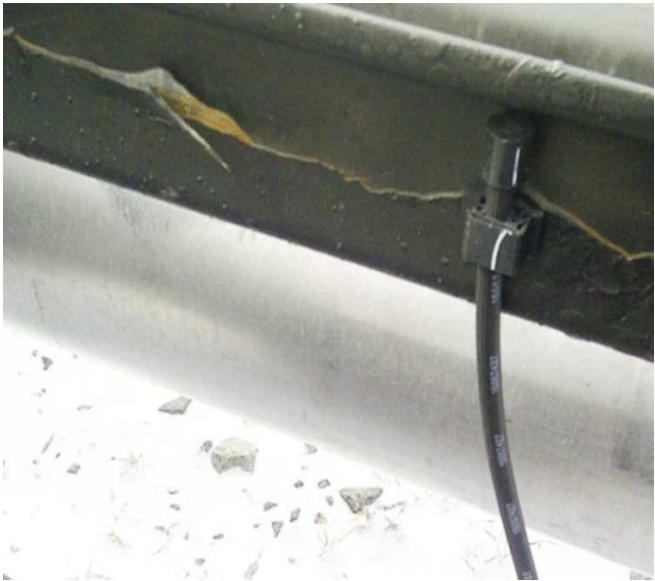
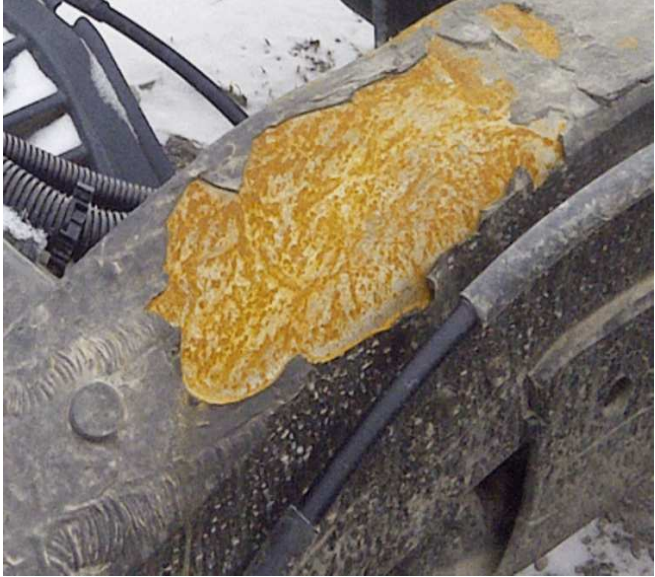
**Van Example Photos**
