# Service Bulletin

Bulletin No.: 19-NA-277

**Subject: Poor Fuel Transfer and/or Rear Fuel Tank Collapsed, DTCs P2635, P2636, P2A00 and/or P026D Set**

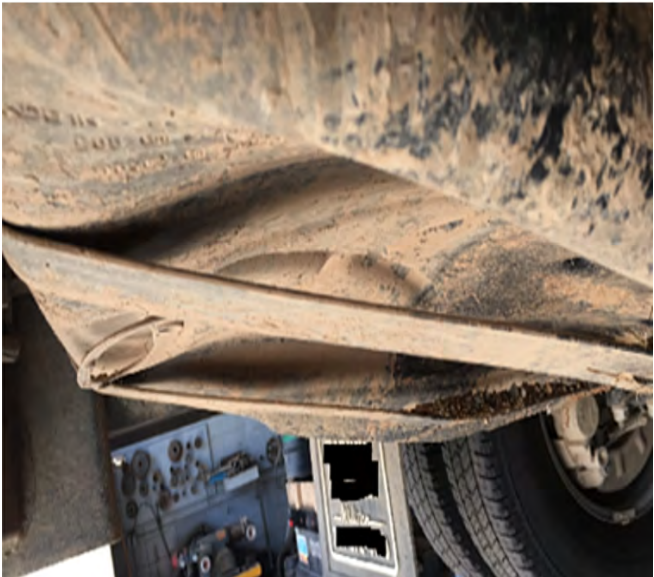
<p style="text-align: right; font-size: small;">5396125</p> <p>Some customers may comment on the rear fuel tank collapsed, as shown in the picture above.</p> <p>Technicians may find one or more of the following DTCs set.</p> <ul style="list-style-type: none"> <li>• P2635 - Fuel Pump Flow Performance</li> <li>• P2636 - Fuel Pump 2 Flow Insufficient</li> <li>• P2A00 - HO2S Performance Sensor 1</li> <li>• P026D - Injection Quantity Too High</li> </ul>

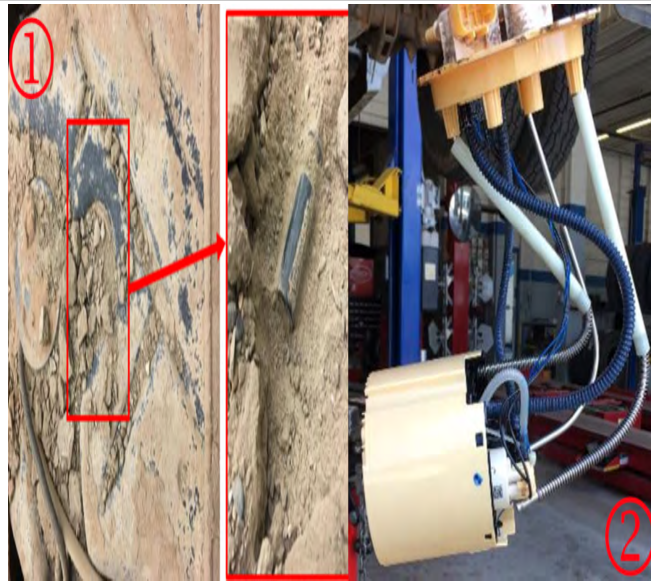
5397974

This condition may be caused by dirt and/or debris collecting on the top of the rear tank (1), plugging the vent causing the sending unit to draw air and bend the fuel tank fuel pump (2), as shown in the picture above.
