# Service Bulletin

Bulletin No.: 20-NA-021  
Date: August, 2020

**Subject:** Intermittent Service Steering Column Lock message displayed with U0155 Set

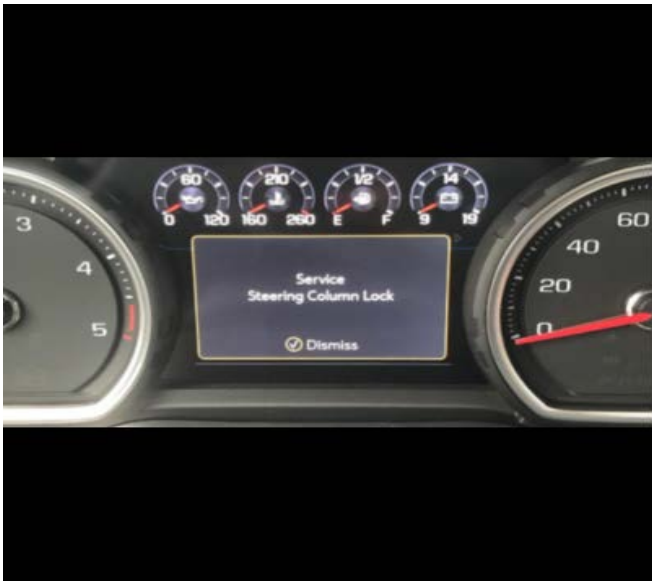
5500772

<b>Involved Region or Country</b>	United States, Canada, Mexico, Middle East and Israel.
<b>Additional Options (RPOs)</b>	
<b>Condition</b>	<p>Some customers may comment on a "Service Steering Column Lock" message displaying that may clear when the engine is started. A technician may find DTC U0155 set/stored in vehicles history.</p> <ul style="list-style-type: none"> <li>DTC U0155: Lost Communication with Instrument Cluster</li> </ul>

<b>Cause</b>	The cause of the condition may be the program in the Steering Column Lock Module is not optimized to the wake up signals on the communication bus.
<b>Correction</b>	Reprogram the Steering Column Lock Module with the latest software, refer to <i>K60 Steering Column Lock Module: Programming and Setup</i> in SI.
