# Service Bulletin

Bulletin No.: 20-NA-126

**Subject: Water Leak in Rear Compartment**

Brand:	Model:	Model Year:		Engine:	Transmission:
		from	to		
Chevrolet	Malibu (VIN Z)	2016	2016	All	All
	Malibu	2017	2020

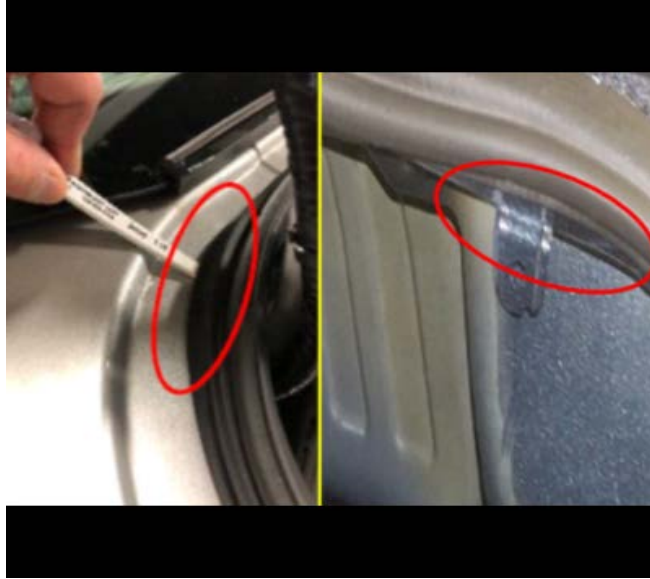
5607849

- The rear compartment lid weatherstrip may not be fully seated around the trunk opening or around the corners of the deck lid hinges.

9. Remove the rear compartment lid weatherstrip (1), if not yet removed. Install the NEW rear compartment lid weatherstrip. Refer to *Rear Compartment Lid Weatherstrip Replacement* in SI.

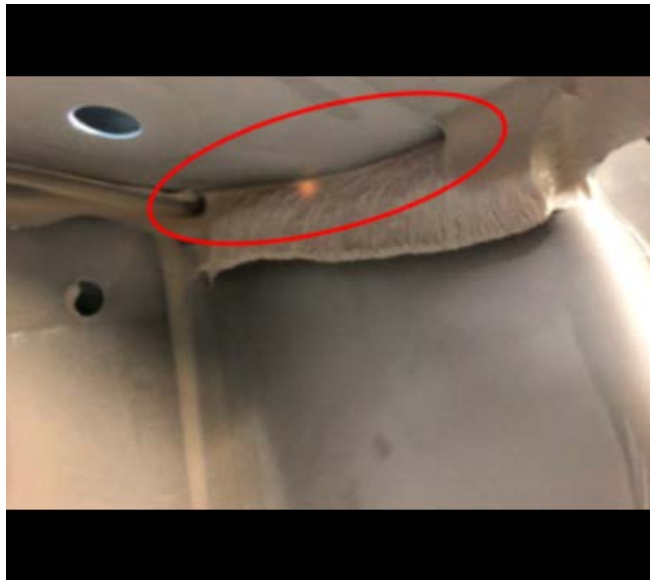
5607851

- Trunk body sealant may have been misapplied at the left tail lamp pocket, creating a leak path and potentially allowing water to leak into the trunk.

5. Apply a generous bead of Kent® High-Tech Seam Sealer Clear P10200, or Wurth Euroseal Gel Clear 18920104, or equivalent, at the left rear combination lamp opening.

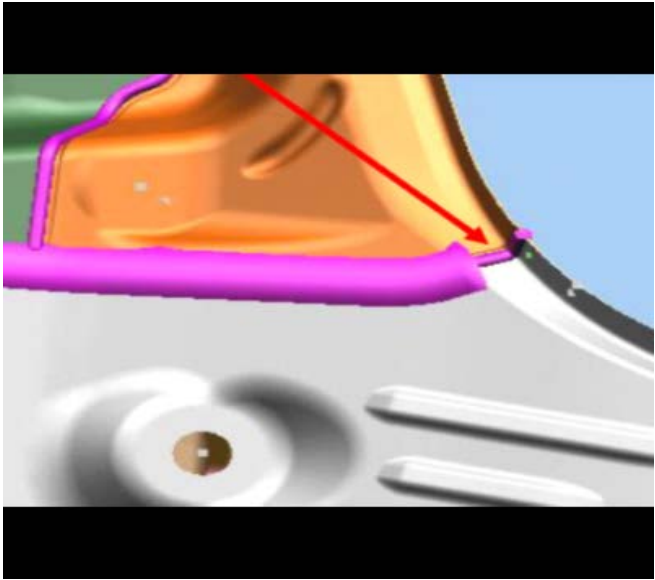
<p data-bbox="1419 739 1484 758">5607853</p> <ul data-bbox="542 779 1438 835" style="list-style-type: none"><li>• Body sealant may not have been properly skived along the left flange of the deck lid opening, which may not allow the weatherstrip to fully seat properly.</li></ul>
<p><b>Correction</b></p>	<p>For vehicles showing the condition, verify the VIN breakpoint and follow the appropriate recommended repair steps in the Service Procedure below.</p>

6. Locate the improperly skived sealer along the left flange of the deck lid opening. The location is shown in the graphic above.
7. Also apply a generous bead of sealer to close the skive void along the left flange of the deck lid opening.
8. If removed, reinstall the left rear tail lamp. Refer to *Rear Body Structure Stop Lamp Replacement* in SI.

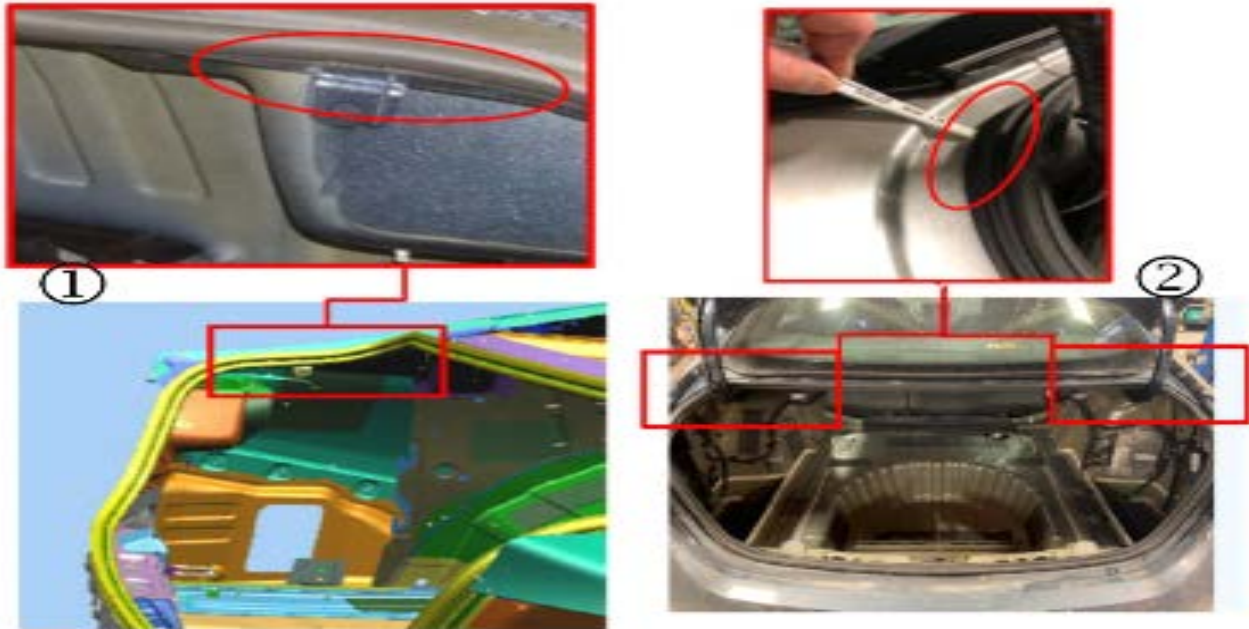
5610529

**Note:** The areas noted by callout (1) are body seams that are more commonly known to be missing sealer. The areas noted by callout (2) are areas where the rear compartment lid weatherstrip is more commonly found to be not fully seated.

1. Water Test the rear compartment, specifically addressing the possible leak path areas noted above.
  - If NO water leaks are evident, NO further repairs specified in this bulletin should be completed. Further discussion should take place with the customer regarding the possible source of the original water found, or further testing may be necessary.
  - If water leaks ARE evident AND the vehicle was built prior to VIN # G1ZB5ST6LF077651 continue ahead to **step #2** and complete the body sealer repairs and the weatherstrip replacement.
  - If water leaks ARE evident AND if vehicle was build VIN # G1ZB5ST6LF077651, or after, body sealer repairs won't be necessary. Jump ahead to **step #9** and install the NEW rear compartment lid weatherstrip.

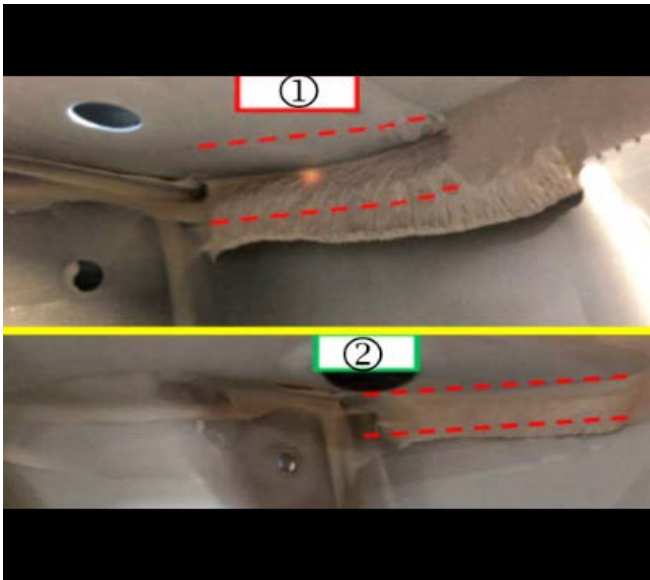
5607855

**Note:** The graphic above shows examples of before (1) and after (2) sealer is applied.
