Service Bulletin

Bulletin No.: 20-NA-142

Subject: Shudder/Surging While Driving

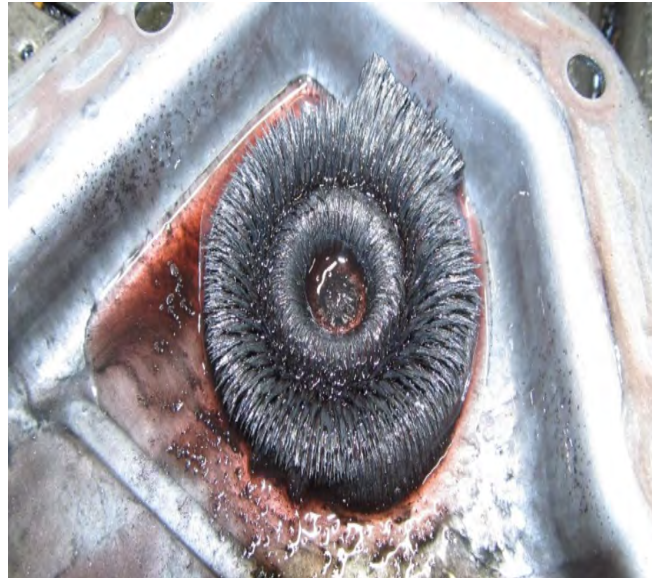
5360216

Involved Region or Country	North America
Condition	Some customers may comment that a surging condition is felt when driving. Some technicians may find during diagnosis or performing PIP5504F, may identify the surging as a torque converter shudder.
Cause	This condition may be caused by additives in the transmission fluid may have been depleted during vehicle operation. – Some of these additives assisted with regulating a consistent slip rate of the clutches.
Correction	<ol style="list-style-type: none"> 1. Raise the vehicle. 2. Remove the transmission pan.

- If metallic debris is present remove transmission and replace torque converter, replace filter. Refer to *Torque Converter Replacement* in SI.
- If metallic debris is not present replace the transmission filter, reinstall transmission oil pan and perform the steps in the Service Procedure below.
