Service Bulletin

Bulletin No.: 20-NA-145

Subject: Heated Seat Switch Indicators Inoperative or 110v Power Receptacle Switch Indicator Dimly Lit

Brand:	Model:	Model Year:		VIN:		Engine:	Transmission:
		from	to	from	to		
Chevrolet	Silverado 1500 (New Model)	2019	2019		1GTR9DED7KZ266422 or built prior to May 31, 2019	All	All
GMC	Sierra 1500 (New Model)	2019	2019

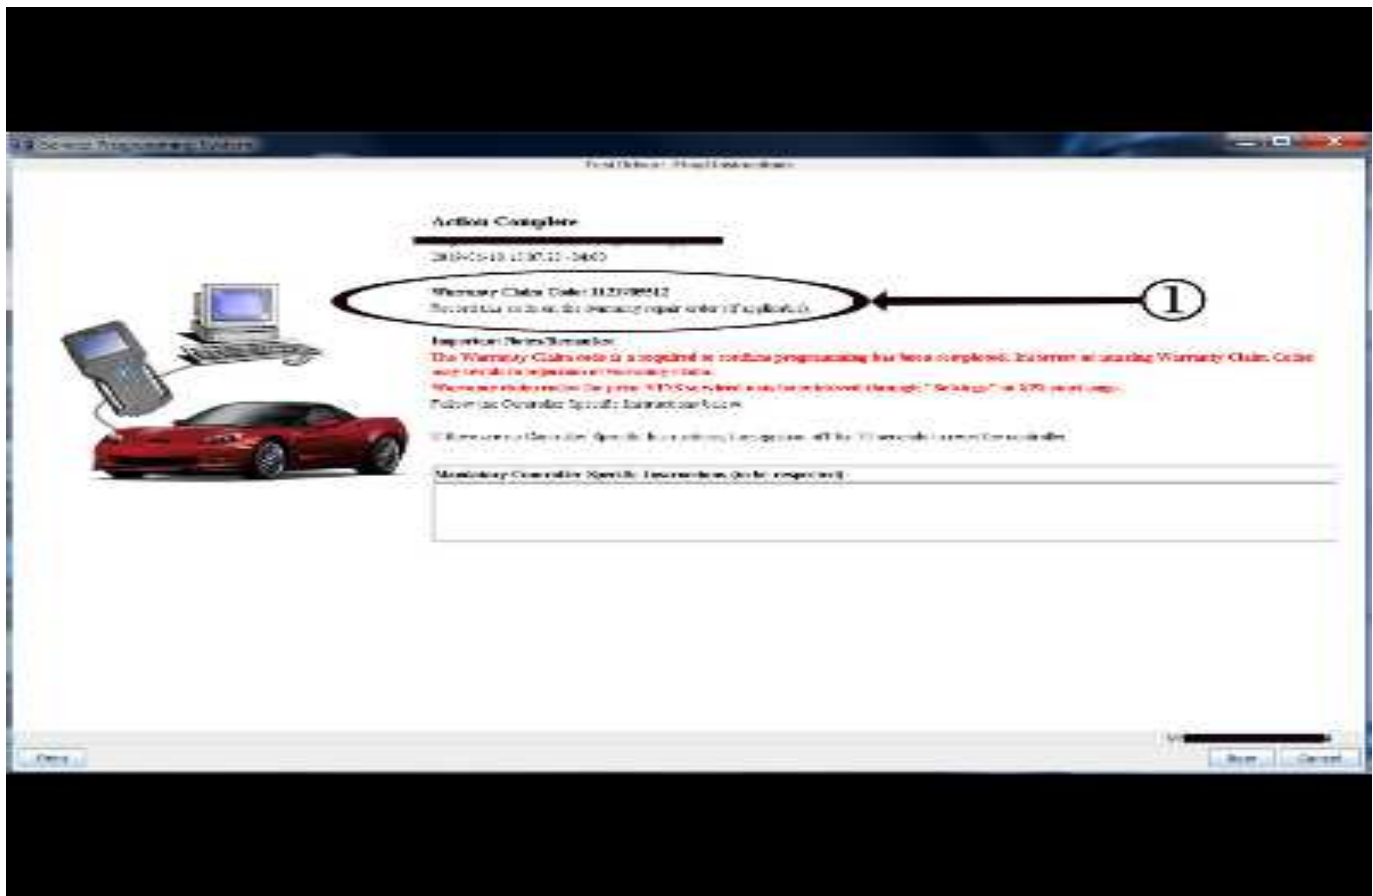
5431209

Important: TIS2WEB screen shown. Techline Connect screen is similar and will be included soon.

Important: To avoid warranty transaction rejections, you **MUST** record the warranty claim code provided on the SPS Warranty Claim Code (WCC) screen on the job card. Refer to callout 1 above for the location of the WCC on the SPS screen

2. Record SPS Warranty Claim Code on job card for warranty transaction submission.
