# Service Bulletin

Bulletin No.: 20-NA-146  
Date: August, 2020

**Subject:** Front End Noise While Driving at Highway Speeds

Brand:	Model:	Model Year:		VIN:		Engine:	Transmission:
		from	to	from	to		
Chevrolet	Blazer	2020	2020			All	All

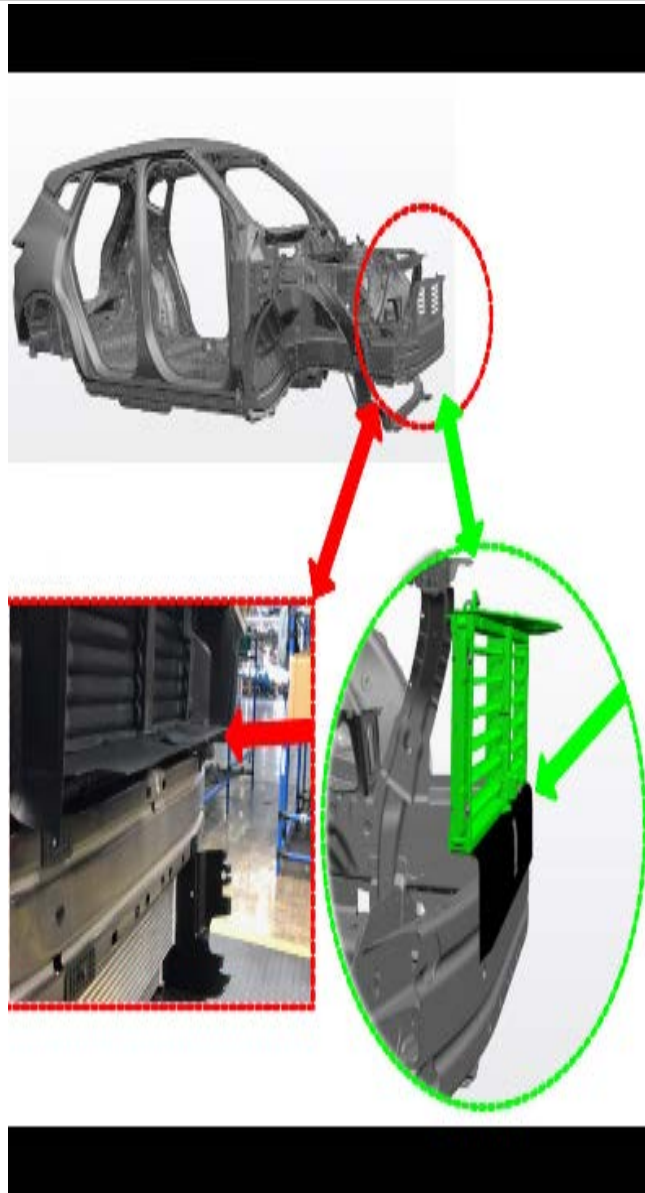
5634996

**Note:** The illustration above shows the correct orientation in GREEN, and the incorrect orientation in RED.

The front upper aero shutter lower air guide seal is not properly nested between the front impact beam and the front fascia grille blocker / EA foam. The lower air guide seal may not have the proper preform, allowing for it to lay on top of front fascia grille blocker / EA foam. When laying on top of the grille blocker (instead of tucked between grille blocker and front impact beam) the rubber seal may produce above mentioned type noise due to exposure to highway speed winds.
