Service Bulletin

Bulletin No.: 20-NA-147

Subject: Sharp Edge on Lower Outboard Corner of a Front Side Door Lower Molding

Brand:	Model:	Model Year:		Date Breakpoint:		Engine:	Transmission:
		from	to	from	to		
GMC	Terrain	2018	2020	-	-	All	All

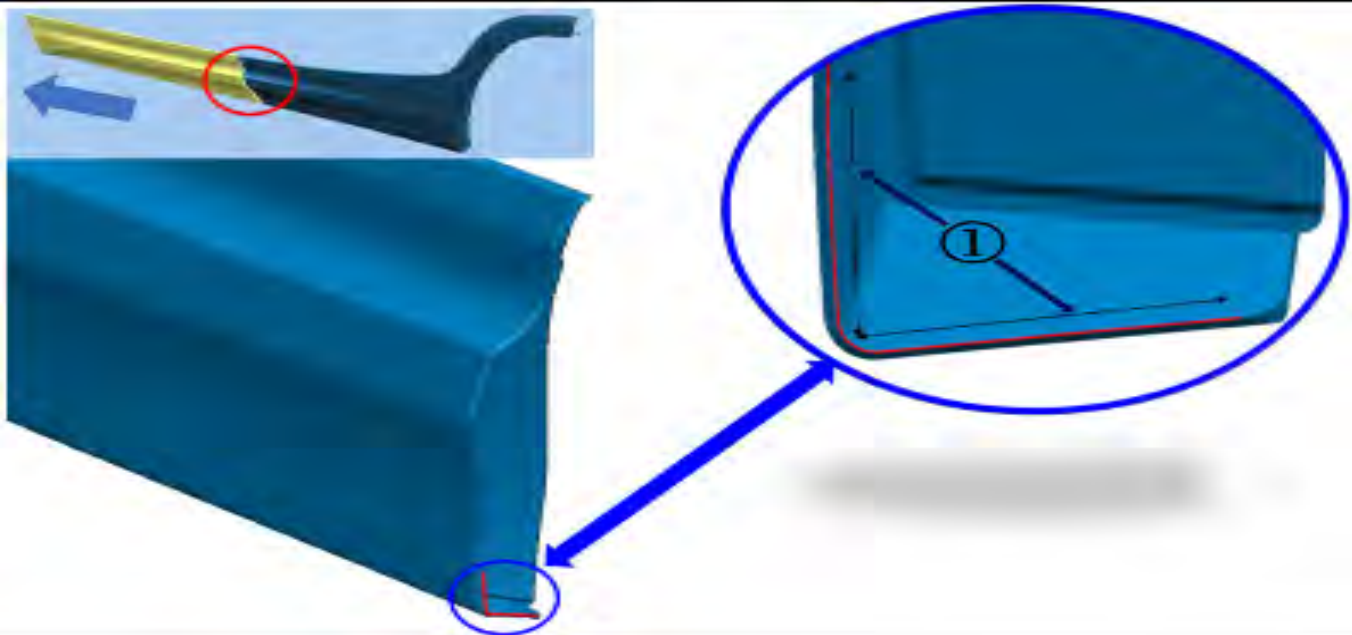
5633773

Involved Region or Country	North America, Middle East
Additional Options (RPOs)	—
Condition	Some customers may comment on noticing, or feeling, a sharp edge on the lower outboard corner of the front door lower molding. This condition can exist on either, or both, side front doors.
Cause	The cause of the condition may be excess flashing material created during the production process.
Correction	Inspect both sides of the vehicle to verify the condition, then repair following the steps in the Service Procedure below.

1. Starting on either side front door, open the door and inspect the front side door lower molding at the outboard rear corner.

Note: Sand approximately an area 30 mm x 30 mm (1.20 in x 1.20 in) (1) inboard from the corner of the molding.

Note: DO NOT replace the front side door lower molding for this sharp edge condition.

2. If a sharp edge is verified, using 400 - 600 grit sandpaper, very lightly sand the sharp edge surfaces of the molding, to a smooth roundness.
3. Close the door and repeat steps #1 and #2 on the opposite side.
