# Service Bulletin

Bulletin No.: 20-NA-148

**Subject:** Plastic to Metal Squeak/Creak Noise Heard Coming from the Driver or Passenger Side B-Pillar Area

Brand:	Model:	Model Year:		VIN:		Engine:	Transmission:
		from	to	from	to		
Chevrolet	Traverse	2020	2020			All	All

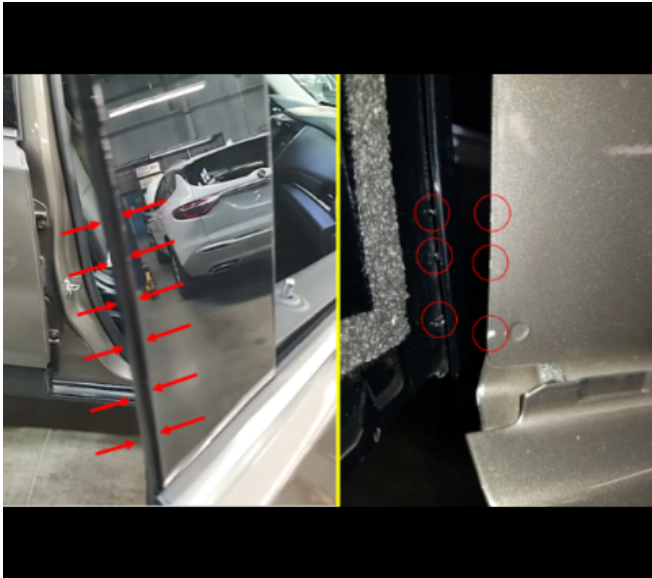
5633856

**Note:** The common area most effected is shown in the left graphic above, and visual wear markings that may be visible on the paint, which could assist with identifying affected areas, is shown on the right.

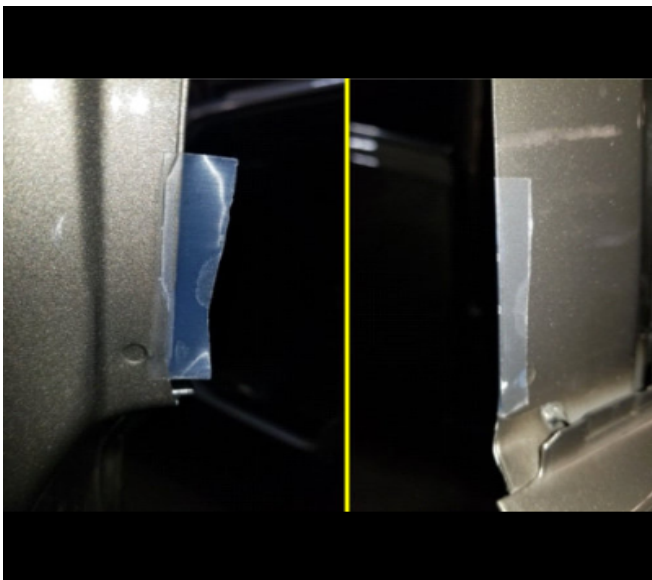
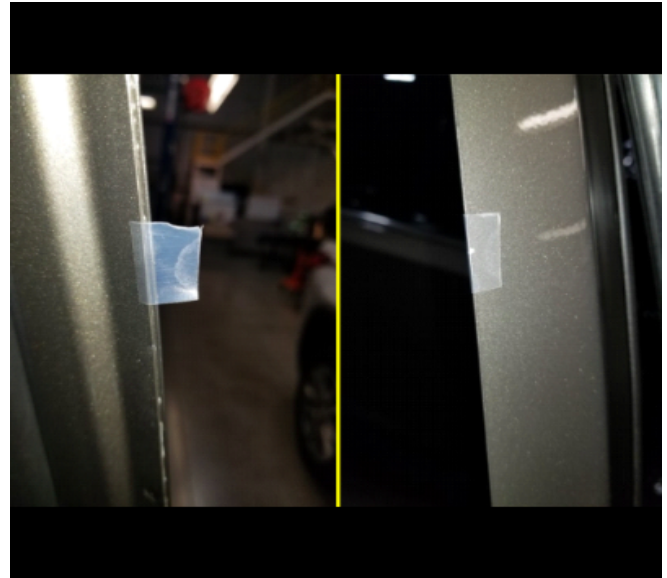
**Note:** Some examples of the common tape application locations are shown in the graphics above.

2. Apply strips of Kent Automotive Anti-Squeak Film Tape # KT13512, or an equivalent UHMW Polyethylene anti-squeak tape, to the affected areas on the B-Pillar of the front side door window frame where the rear applique connects.
