SIB 18 02 20

DELIVERY STOP: INSPECT NUTS ON CATALYTIC CONVERTER

E-Series	Model Description	Production Date
G05	X5 Sports Activity Vehicle	March 10, 2020 - June 1, 2020
G06	X6 Sports Activity Coupe	March 18, 2020 - June 1, 2020
G07	X7 Sports Activity Vehicle	March 23, 2020 - June 1, 2020

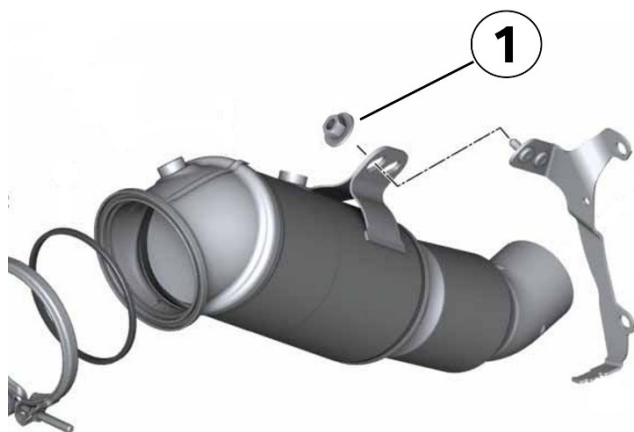
The nuts on the catalytic converter bracket in the engine compartment have been incorrectly torqued (19 Nm instead of 28 Nm).

Check which type of nuts (1) are present on the holder of the catalytic converter and, if necessary, tighten the nuts to proper specification.

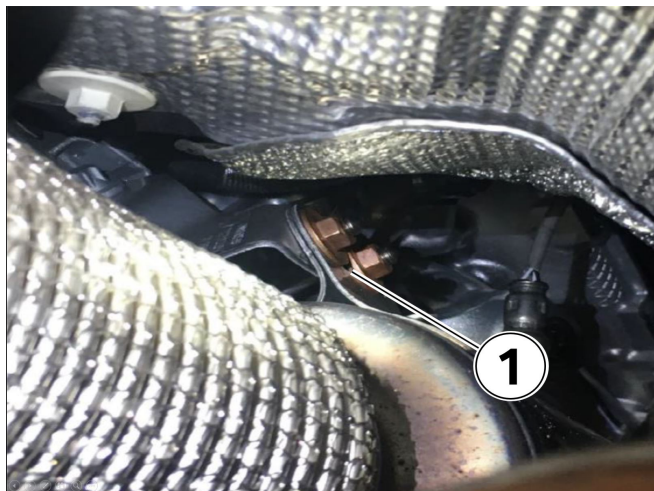
Visually check which type of nuts are on the holder of the catalytic converter (1).

If galvanized nuts (1) are installed, no further repairs are necessary.

If copper nuts (2) are installed, remove the air filter housing as described in the Repair Instruction RA 13 71 000 Remove and install intake silencer housing to access the nuts.

Tighten the existing copper nuts to 28 Nm.

- Do not replace the copper nuts

Reinstall the air filter housing.
