SIB 34 05 17

2020-07-06

## TICKING NOISE WHILE CORNERING WITHOUT THE BRAKES APPLIED

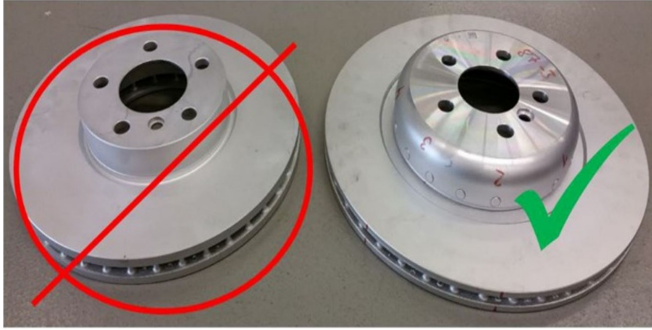
**Are the lightweight discs (shown at right in the photo) installed on the vehicle?**

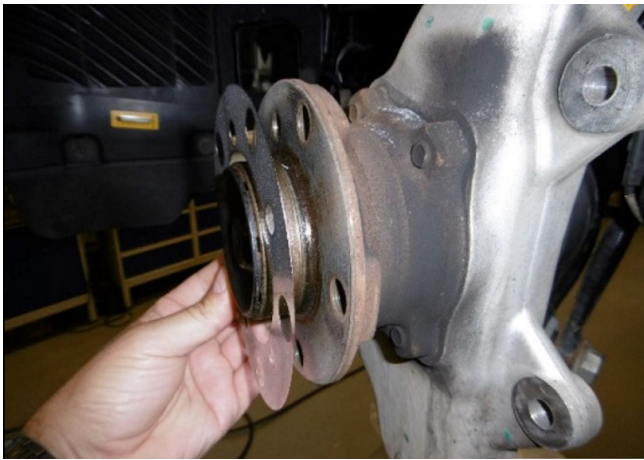
Microscopic movement of the contact interface between the inner brake disc and the wheel bearing flange on vehicles equipped with lightweight brake discs.

5. Install the “friction ring” on wheel bearing flange as shown.

Note: If the vehicle is older than 24 months from production date, replace the wheel bolts on the front and rear axle.
