SIB 51 22 20

2020-07-21

SERVICE ACTION: TIGHTEN UNDERFLOOR BRACING

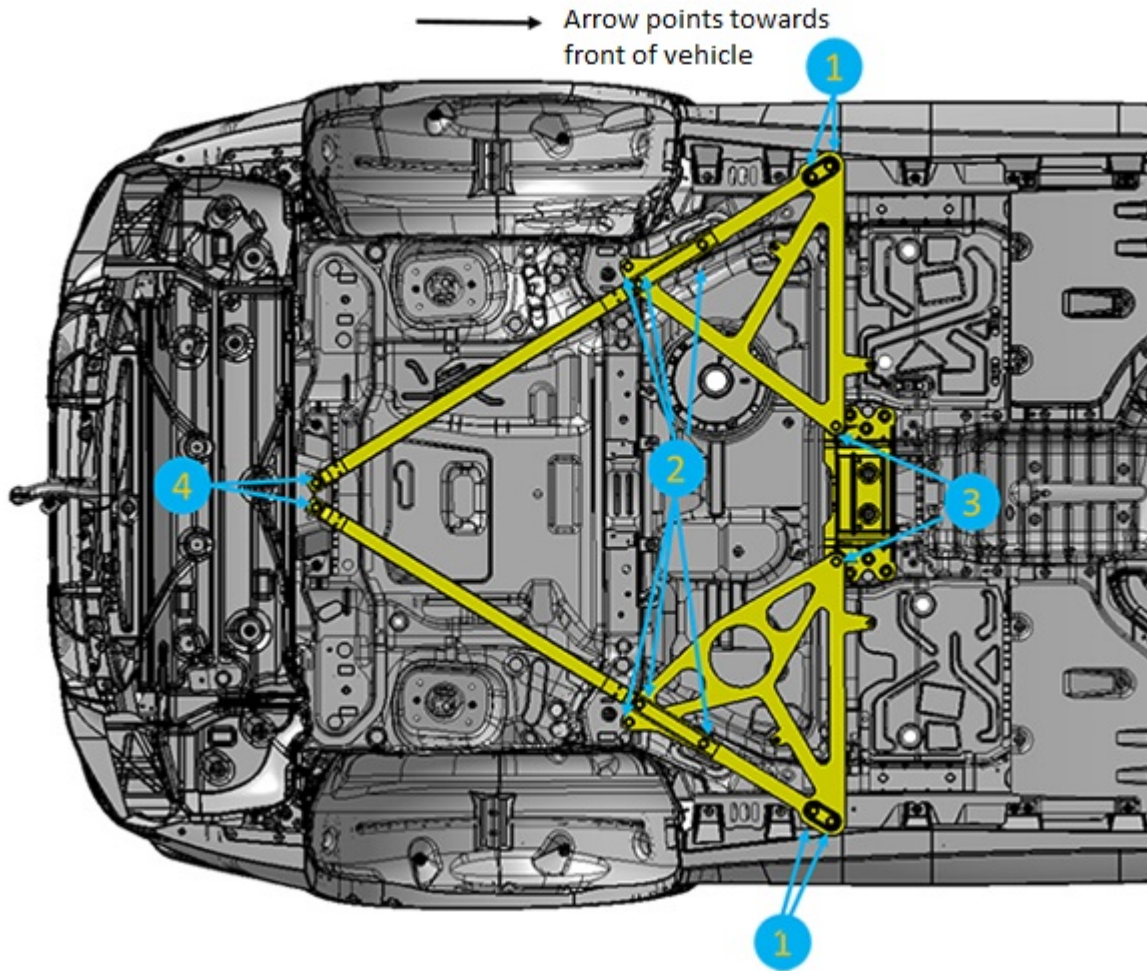
The underfloor bracing was not correctly tightened by the additional 90° required to meet the torque specification during production.

1. Safely secure the vehicle on a lift. Removal of the underbody shields are not required to complete this procedure. All the required bolts are accessible with the vehicle fully assembled.
2. Referencing the photo below, tighten the 14 bolts by 90°, as shown (arrows) in the tightening order of 1-4. Note: Ensure the torque wrench/angle gauge being used can support torque values of up to 250 Nm.
3. After angle torqueing each bolt, **mark the head of the bolt** to track and ensure each bolt has been correctly tightened.

Bolt replacement is not required.

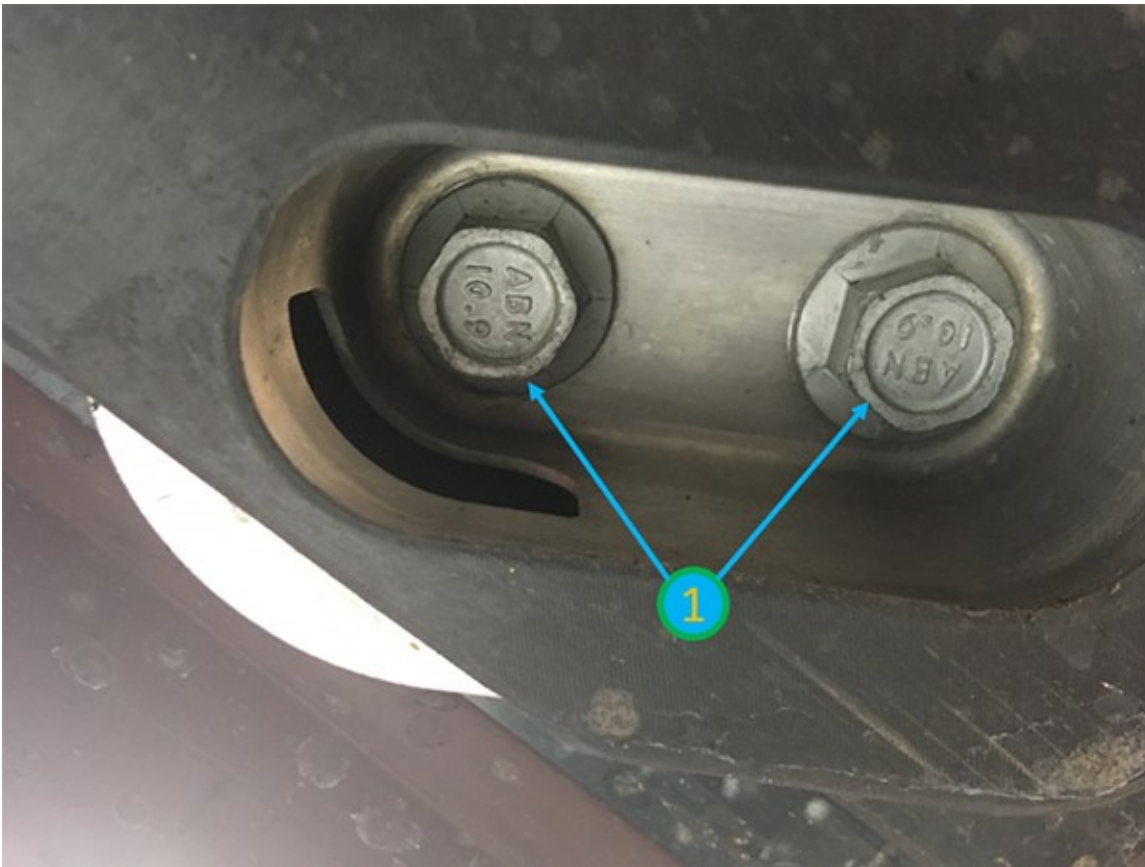
Screw point 1: 2x M12 each on the left and right side of vehicle (4 total):

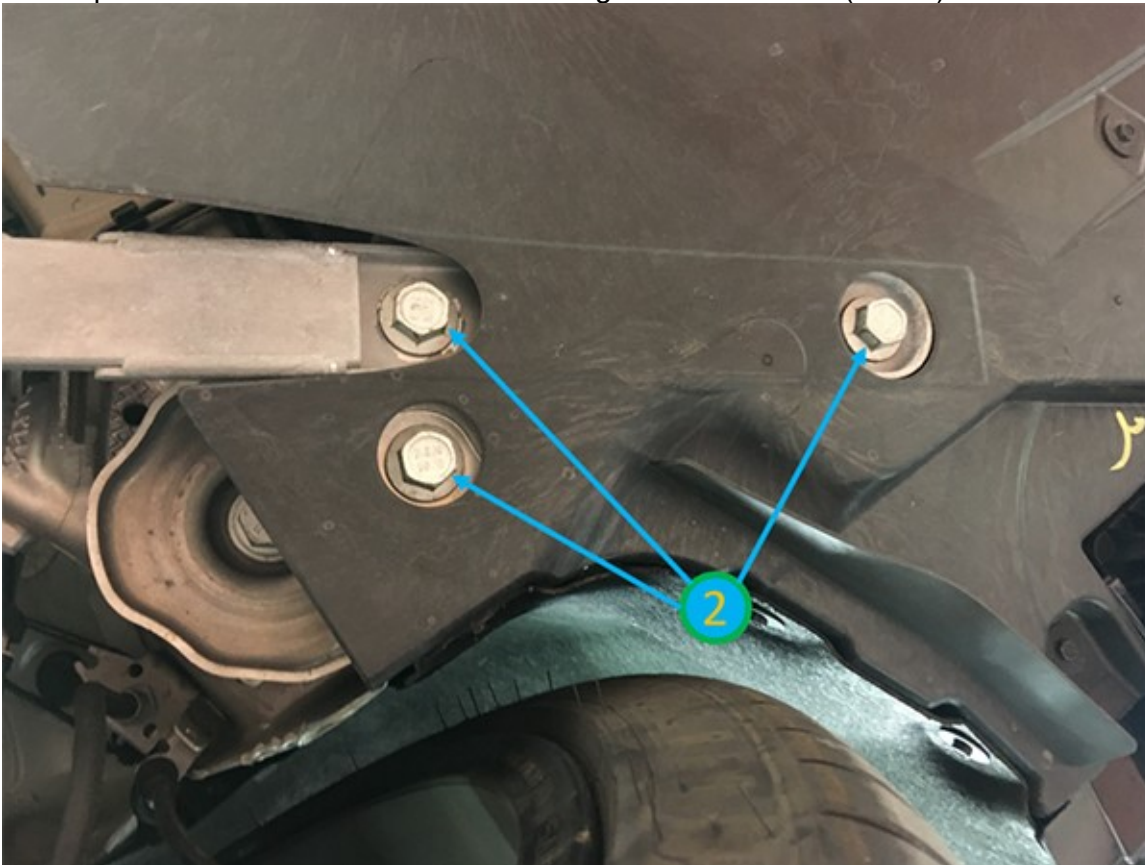
Screw point 2: 3x M12 each on the left and right side of vehicle (6 total):

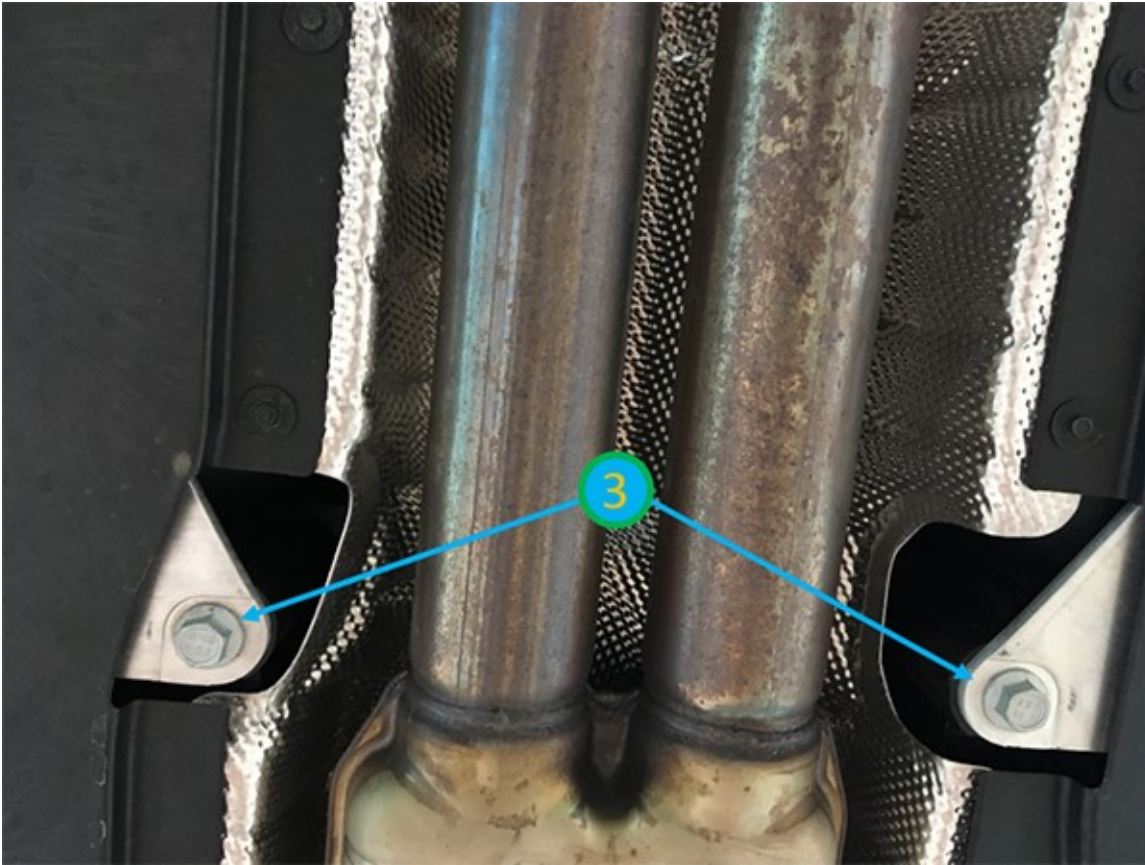
Screw point 3: 2x M12:

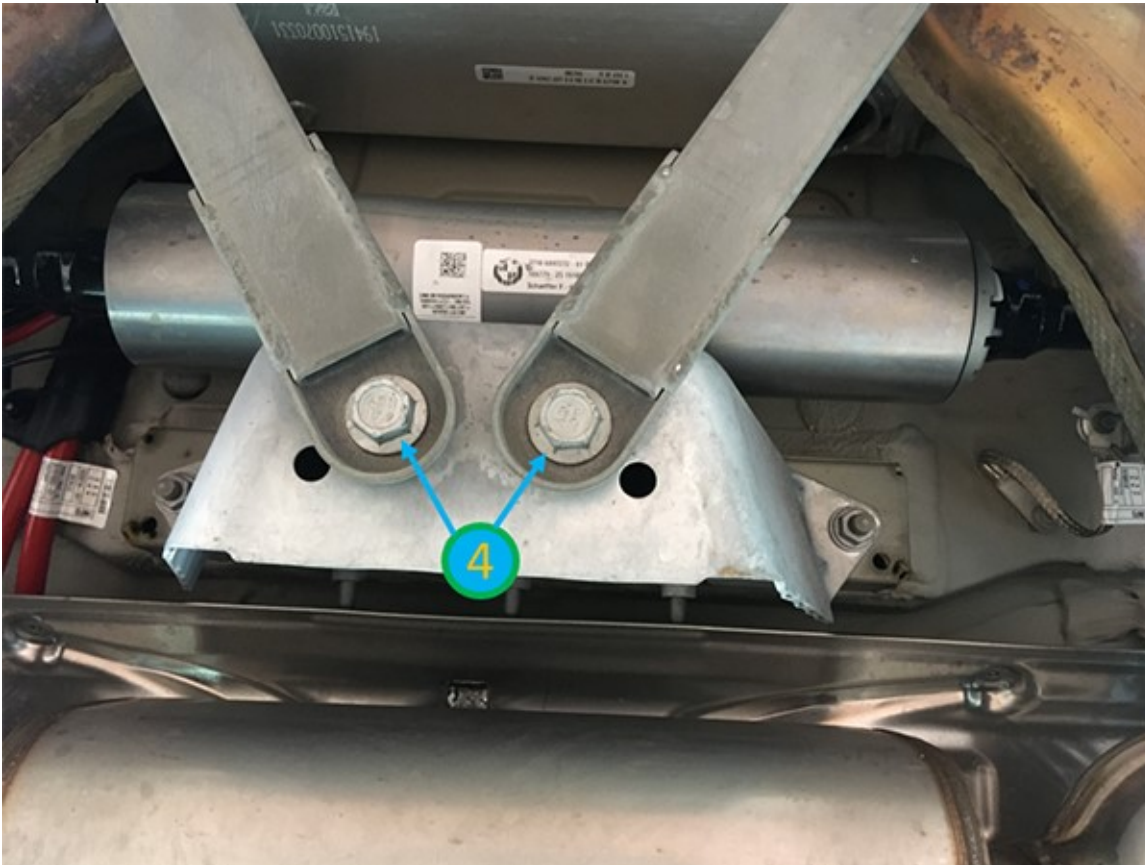
Screw point 4: 2x M12:
