SIB 54 01 20

SERVICE ACTION: CHECK SUNROOF SEALING

2020-07-20

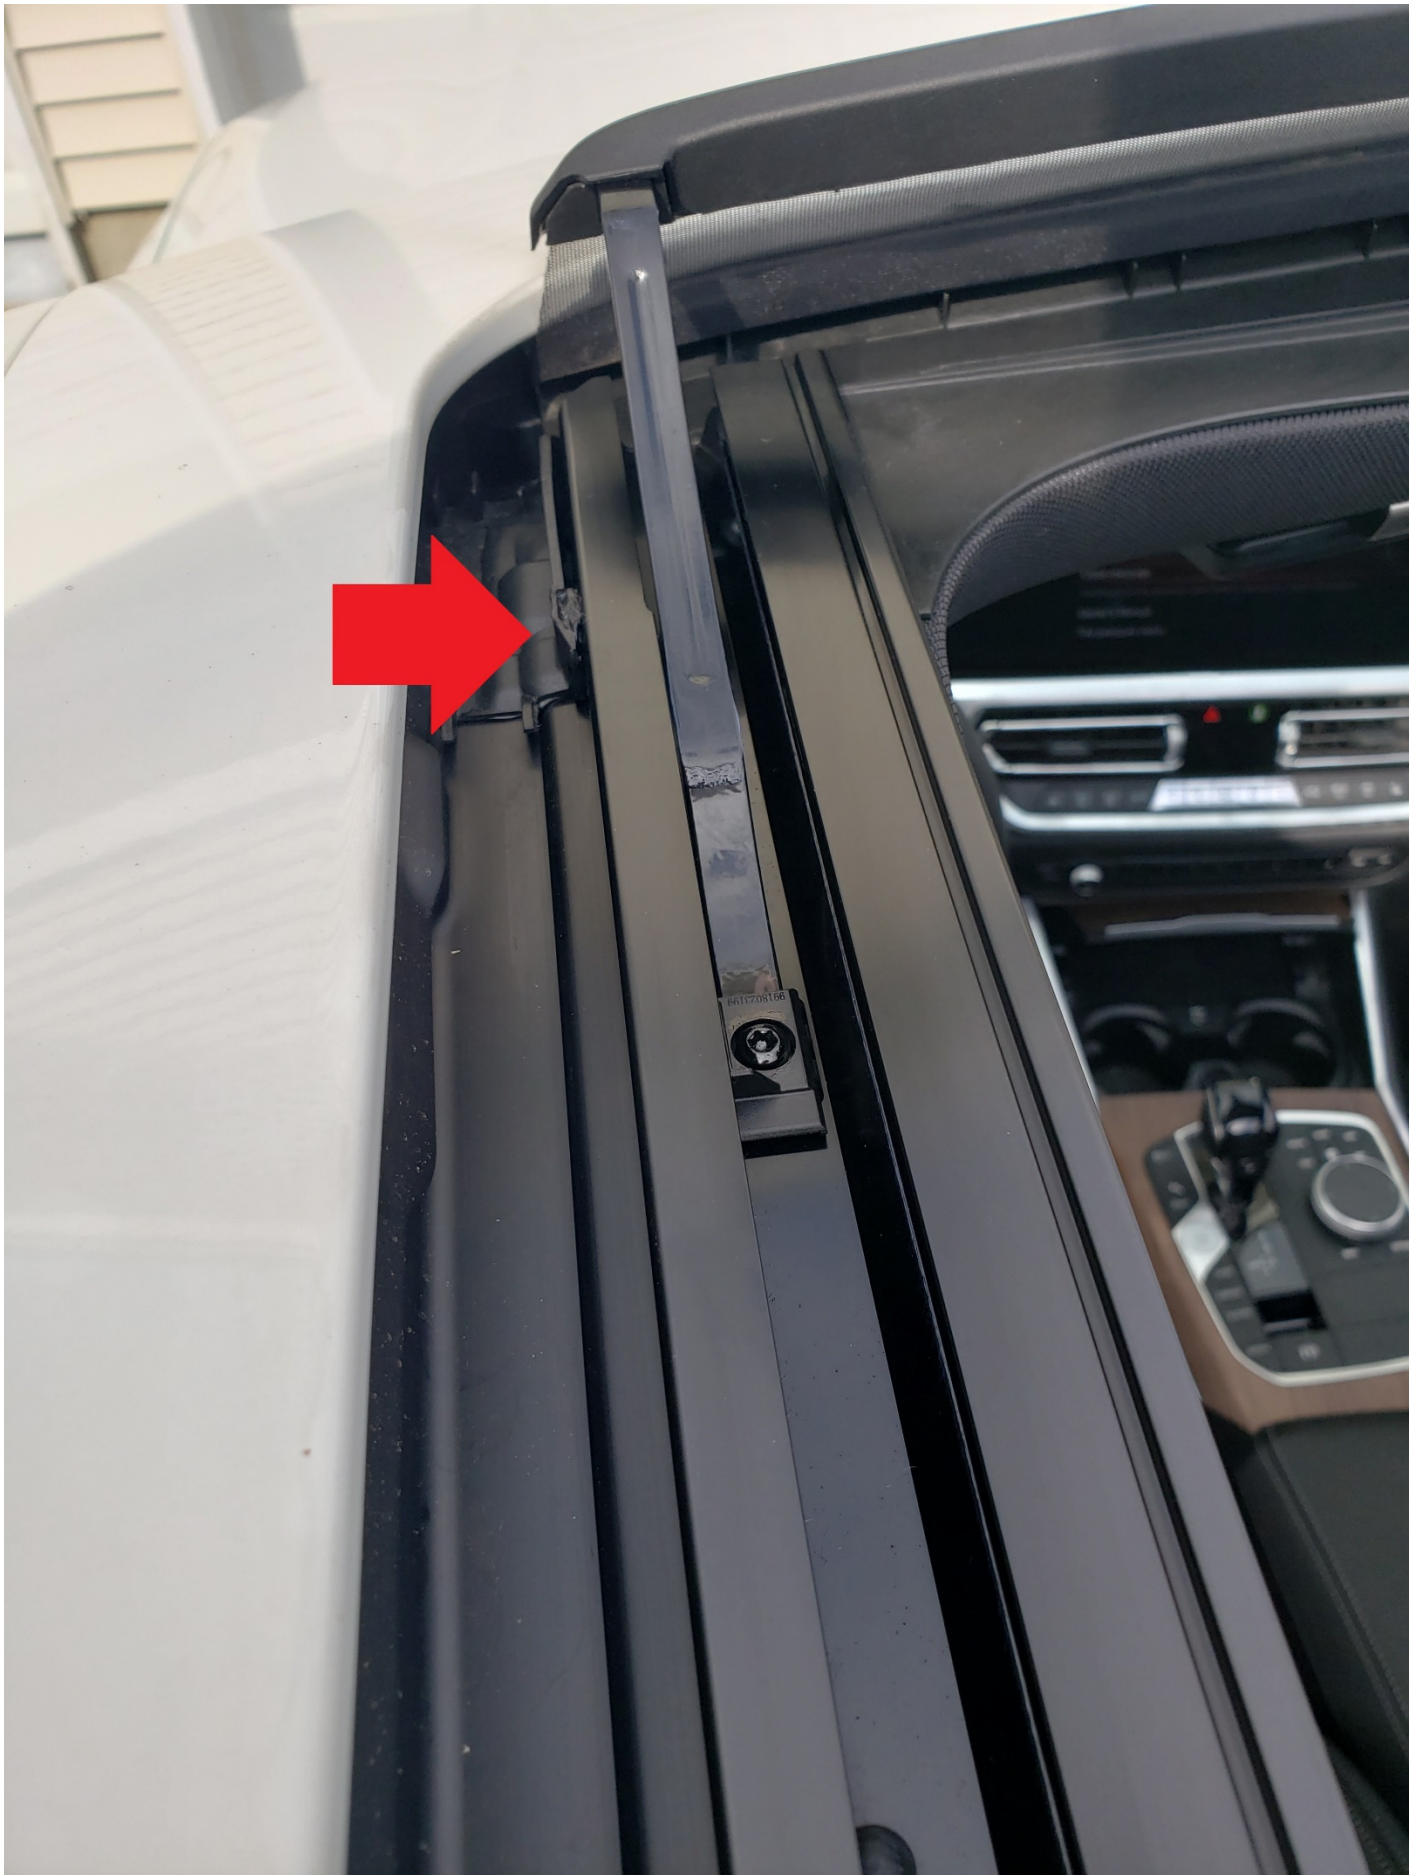
The sunroof frame may not have been properly sealed, causing a water leak into the vehicle.

Improper sealing during production.

1. Open the sunroof completely.
2. Inspect the front corner areas of the sunroof frame as shown below. The arrow below indicates where visible sealer should be present.

3. Is butyl sealer present on both sides (left and right)?

- a. Yes: No further correction is needed.
- b. No: Continue to step 4.

4. Replace the sunroof frame following repair instructions REP 54 12 646 “Replacing glass slide/tilt sunroof frame”.
