SIB 61 16 20

SERVICE ACTION: REWORKING THE HIGH-VOLTAGE SYSTEM CONNECTOR

E-Series	Model Description
G20	330e Sedan

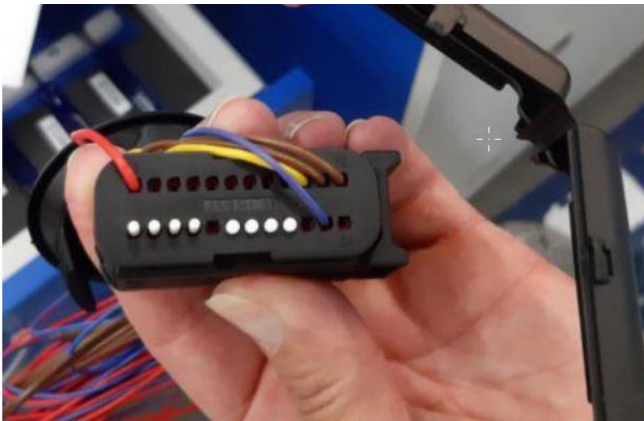
The sealing plugs (aka sealing grommets) on the low-voltage connector to the high-voltage battery were incorrectly mounted.

The white-colored plugs seal off the individual wire chambers in the connector.

Rework the low-voltage connector on the high-voltage battery.

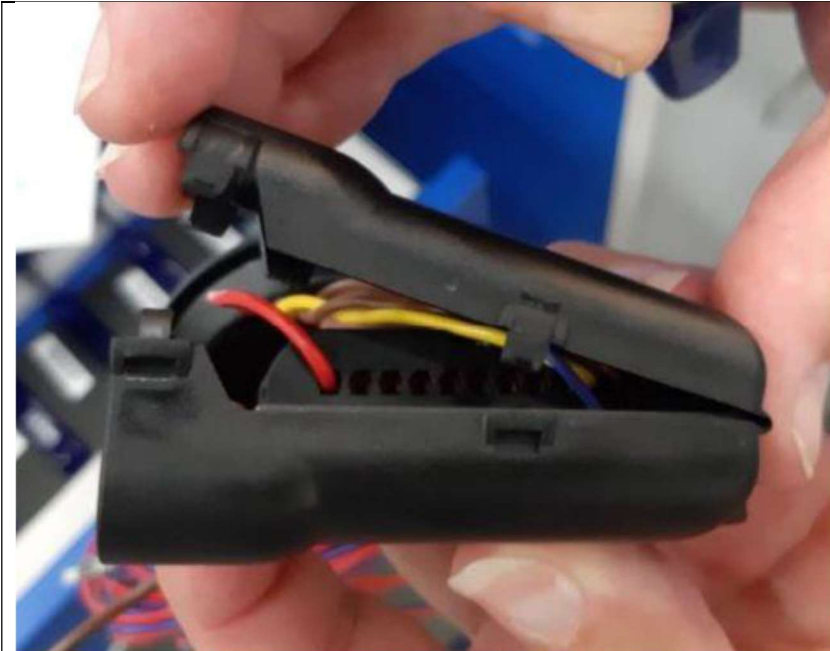
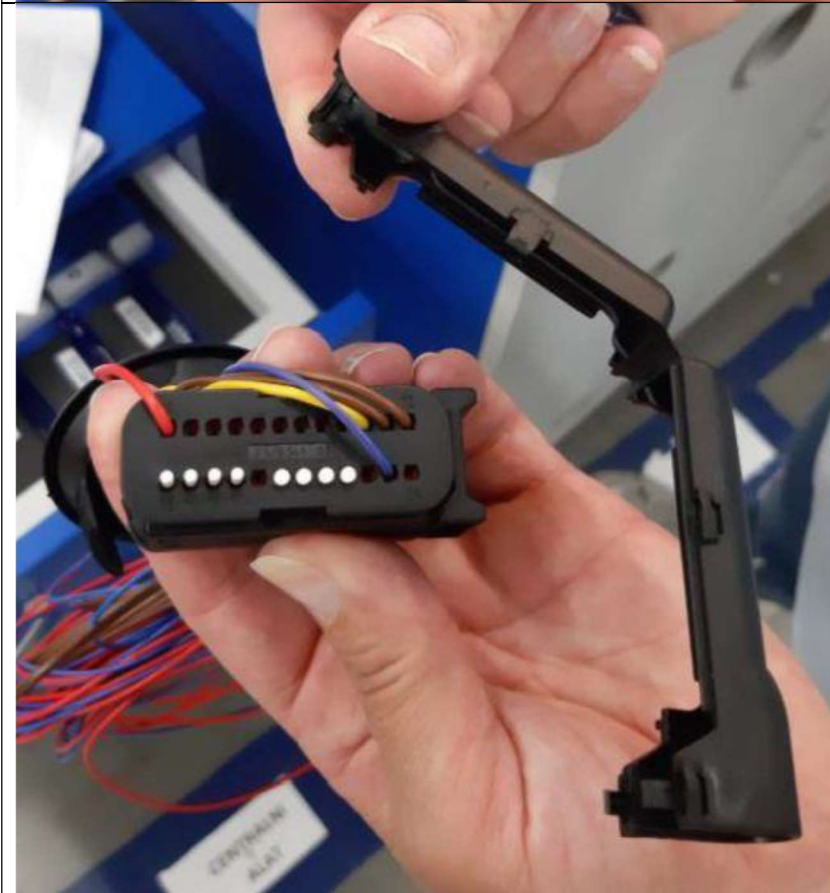
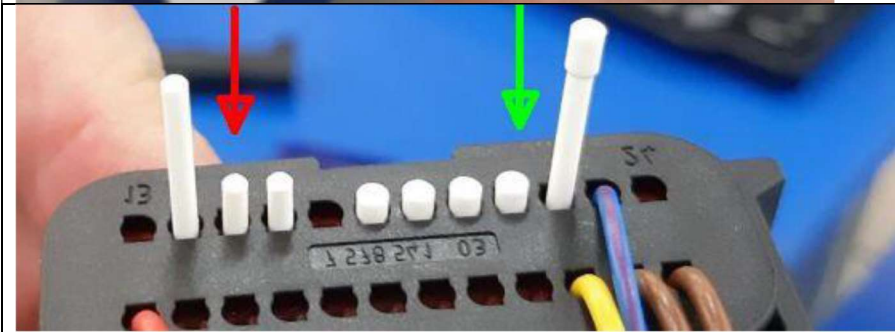
Green, OK

Red, Incorrect

4. Replace all the white sealing plugs on connector A332*1B.

Pay attention to installation direction! The thinner end of the plug is installed first.
