## SIB 62 01 19

2020-07-07

## INSTRUMENT CLUSTER AND ONBOARD COMPUTER INTERMITTENTLY INOPERATIVE

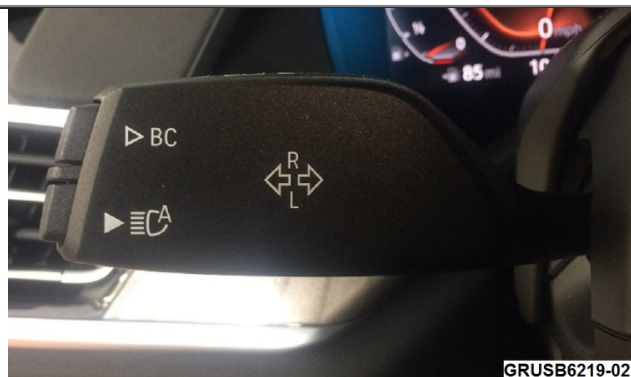
Instrument Cluster (KOMBS18) functions are intermittently inoperative, including:

- On-board Computer (BC) button on turn signal stalk (BC button shown at left)
- Radio displays
- Menu button
- Turn signal displays
- Arrows on multifunction steering wheel
- MFL thumbwheel control (shown at left)

Program the vehicle.

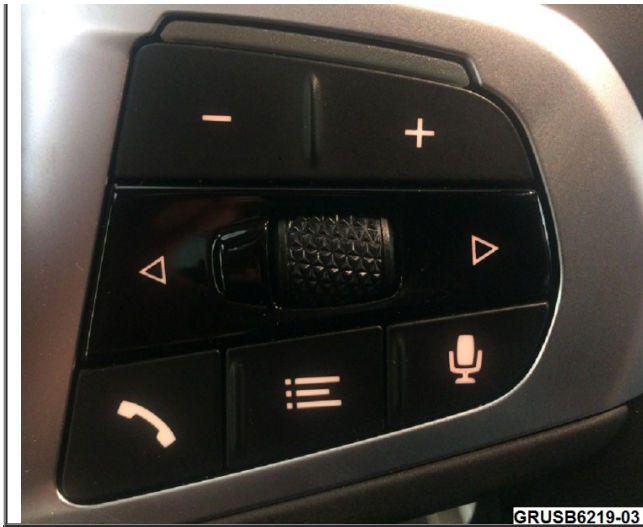
Additionally, the audio source, radio station, or music track cannot be changed using the MFL.
