AWNING ADAPTER

Bulletin Type:	Technical Service Bulletin TSB	Publication Date:	August 2020
Bulletin #(s):	20-018	Make(s):	Entegra Coach
Job Code(s):	9801512	Model(s):	Aspire, Anthem, Cornerstone
Flat Rate(s):	.5 Hour	Model Year:	2020

TSB 20-018 Affected Unit Listing

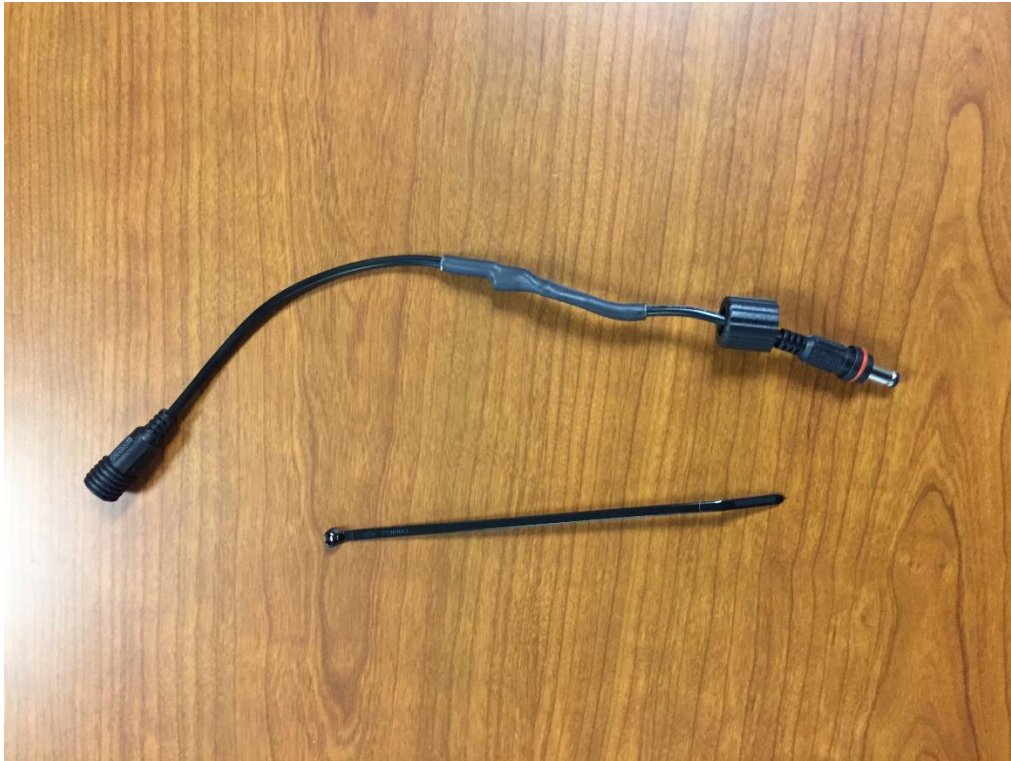
Incident:	The Girard awning may retract when various interior lights are operating.
Affected Units:	Please see the serial number listing at end of the repair instructions.
Parts Kit:	Kit #: 20-018E
	Contents: 2- Pigtail, Sensor motion w/Capacitor (1 per awning) 2 – wire ties (1 per awning)

Below shows, the in-line capacitor and zip tie to install to each of the Girard awnings (2). Awnings are located on the passenger side of the motorhome.
