08/11/2020
CAL FTL 54-010

Subject: New Cascadia ABS Warning Light Illumination

Models Affected: Freightliner New Cascadia

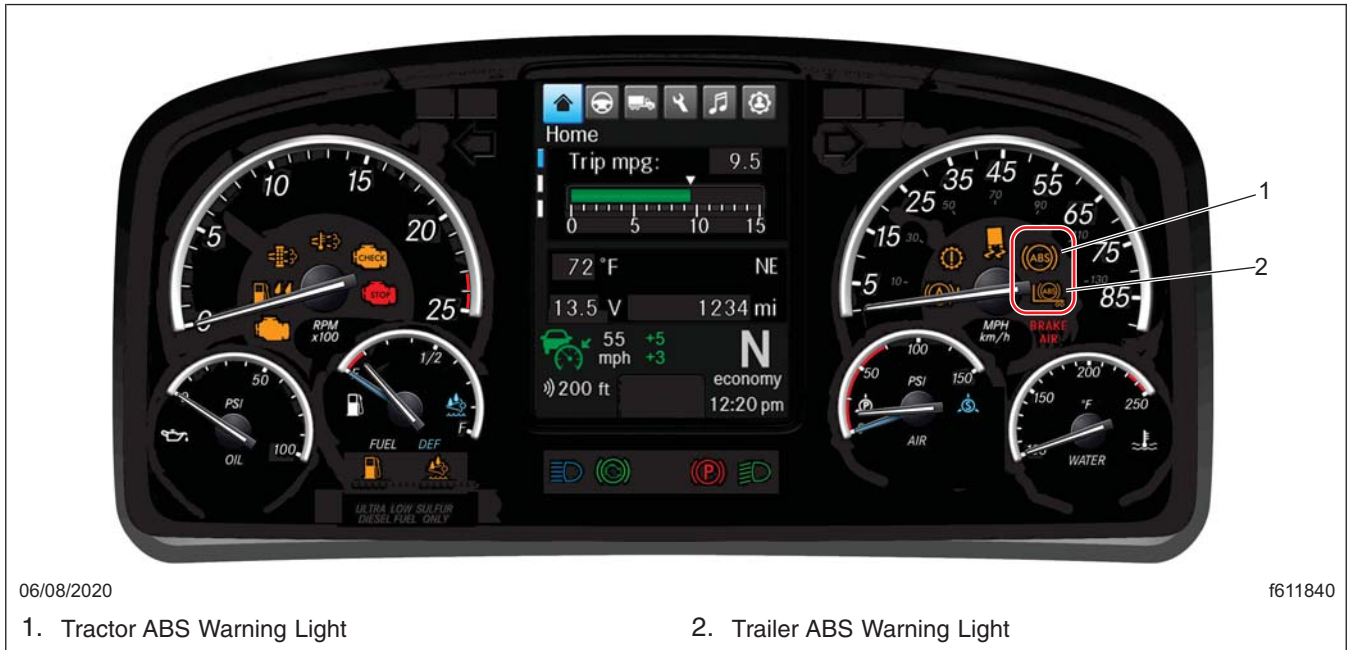
Fig. 1, ABS Telltales on ICUC Instrument Cluster

If a driver experiences loss of cruise control and either or both of the ABS warning telltales appear (see [Fig. 1](#)) as well as the Adaptive Cruise Control (ACC) Unavailable pop-up (see [Fig. 2](#)) and the Active Brake Assist (ABA) Alert pop-up [Fig. 3](#)), pull over safely at the nearest convenient stop or the next planned stop.

Tractor ABS Warning Light	Solid illumination indicates a problem with the vehicle ABS.

Trailer ABS Warning Light	Solid illumination indicates a problem with the vehicle ABS.

To verify if these are legitimate warnings, perform the following steps in order:

1. Set the parking brakes for both the tractor and the trailer.
2. Turn the ignition switch to the OFF position.
3. Turn the cab load disconnect switch (CLDS) to the OFF position

4. Wait a minimum of 30 seconds.
5. Turn the cab load disconnect switch (CLDS) to the ON position.
6. Turn the key to the ON position and verify, after an ICU self-check, that the ABS warning telltales do not remain illuminated.
7. If a code remains after cycling, the vehicle may need to be driven for up to 15 mph (24 kph) to clear it.
8. If the indicator lights remain active after the vehicle is driven up to 15 mph (24 kph), a different situation exists in the ABS functionality of either the tractor, trailer, or both. The vehicle will need to be inspected at an appropriate service facility.
