Technical Service Bulletin

Subject: UNUSUAL ENGINE NOISE AFTER A COLD ENGINE START	Bulletin No.: 01-011/20
	Last Issued: 08/21/2020

2012-2013 Mazda3 (SKYACTIV)	2014-2017 Mazda6	2016-2017 Mazda2
2014-2016 Mazda3	2013-2016 CX-5

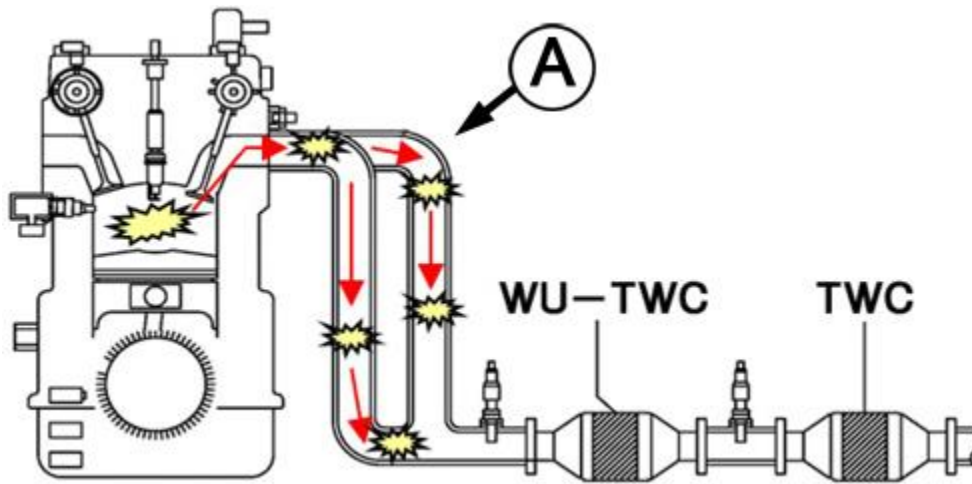
AWS burns fuel inside the exhaust manifold (A) to quickly warm up the catalytic convertor. The customer may identify the burning sound as an unusual noise.
