# Technical Service Bulletin

## 30 Various DTCs stored in the TCM and/or running problems - high maximum temperature recorded for clutch K1

30 20 29 2060560/1 August 31, 2020.

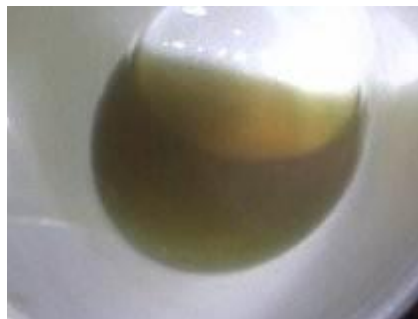
3. Check the transmission fluid by obtaining a sample of the transmission fluid drained in to a white cup. Approximately one inch of transmission fluid in the cup is all that is required. Take a photograph of the fluid with the cup tilted at about 45 degrees for your records (Figure 2). It may be needed if an Audi Technical Assistance Center (TAC) case needs to be opened or for warranty purposes.

**Figure 2.** Fluid photograph example showing approximately one inch of fluid in the white cup, and tilted on an angle to show depth and color.

4. If the measured value for Clutch 1 maximum temperature is about 400 degrees Celsius and the transmission fluid smells burnt and is black or very dark in color, then replace the dual clutch, the transmission fluid, and the transmission filter per the repair manual.
5. If the clutch 1 maximum temperature is not close to 400 degrees Celsius and the transmission fluid is not black or very dark in color then this TSB does not apply. Open an Audi Technical Assistance Center (TAC) case with pictures of the transmission fluid picture attached and your diagnosis information. Then contact the Audi Technical Assistance Center (TAC).
