SS 1034761 P3 - CEL On and Engine de-rate due to ATD Chassis Harness Circuit 532M5+ at DEF Heater Supply location is shorted

FTL P3 - Cascadia

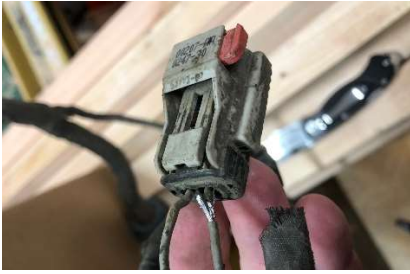
Harness part number A66-03217-002 has been reported experiencing failures due to damages to 532M5+ circuit shorting /or corrosion in terminals at Connector (23-13053-200) harness location "ATD_CHAS_F_O_HTR_LINE_DEF_5B" .

Circuit 532M5+ Damaged at DEF Heater Line Connector:

Connector backshell is available to be added at the location indicated to add extra protection to wiring and also reduce or eliminate terminal corrosion.

Required part number: 23-13302-633 -- Backshell

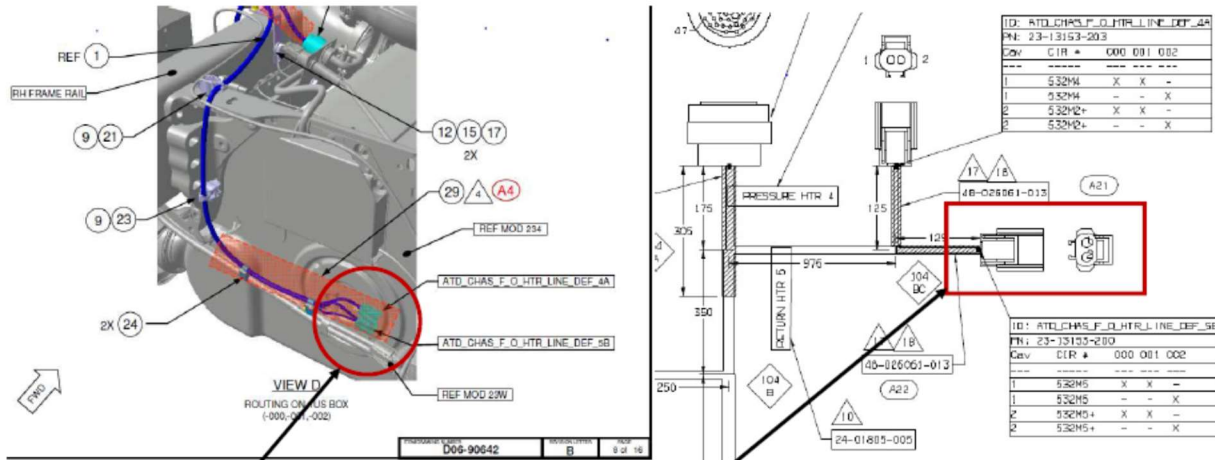
Main ATD Harness Installation:

A66-03217-002- ATD Chass-Harn Break-Out location: **ATD_CHAS_F_O_HTR_LINE_DEF_5B**

Addition of Back Shell 23-13302-633 to Connector 23-13153-200in ATD Chassis Harness A66-03217-002
