# TECHNICAL SERVICE BULLETIN

## 2020 Explorer/Aviator - Exhaust Rattle Noise

**20-2282**  
20 August 2020

<b>Ford</b> 2020 Explorer
<b>Lincoln</b> 2020 Aviator

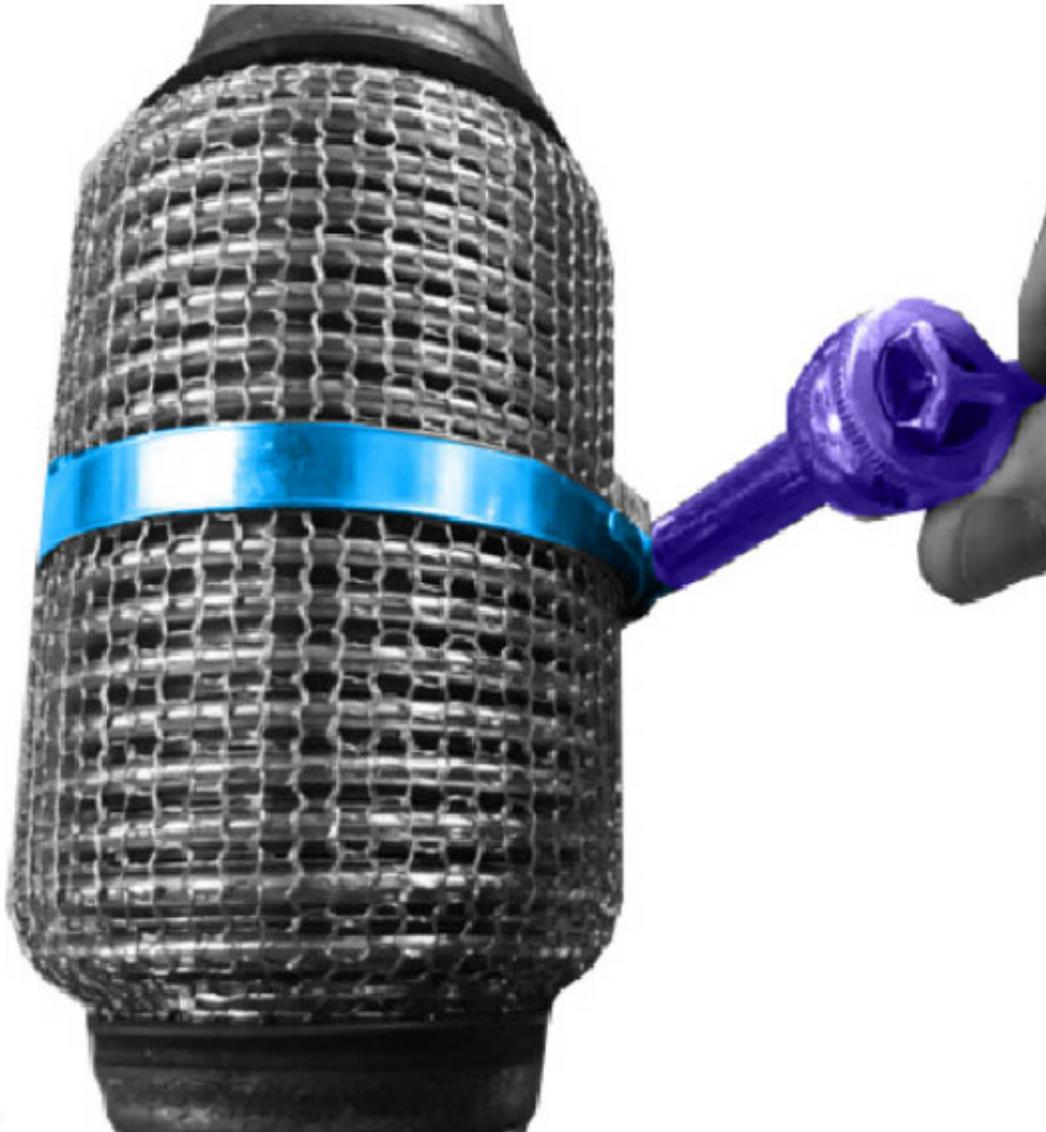
Figure 1

**Issue:** Some 2020 Explorer/Aviator vehicles may exhibit a rattle type noise originating from the exhaust flexible pipe. This may be due to the natural harmonic frequency of the pipe. To correct the condition, follow the Service Procedure to install a worm gear clamp over the exhaust flexible pipe.

1. Open and install the worm gear clamp over the flexible portion of the exhaust flexible pipe. Tighten to 2.7 Nm (24 lb-in) (Figure 1).
