# Service Alert

<b>Subject:</b> <b>ENGINE NO START DUE TO LOW BATTERY VOLTAGE</b>	<b>Service Alert No.:</b> SA-054/20
	<b>Last Issued:</b> 08/10/2020

2019-2020 Mazda3  
2020 CX-30

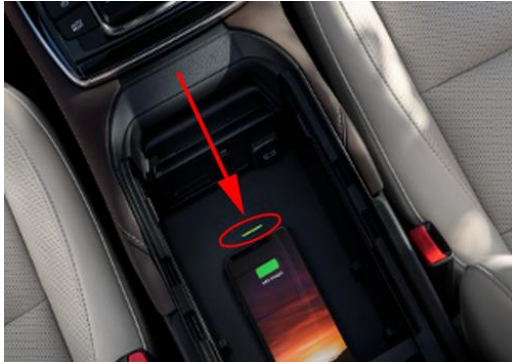
3. Turn the ignition OFF.

**Is the Mazda Wireless Charger LED indicator is ON?**

- Yes:
  - Mazda3 -The Mazda Wireless Charger installation is incorrect. Replace the Mazda Wireless Charging kit and install it using the North America installation instructions (go to MXConnect - Parts and Accessories - Accessories - Genuine Mazda Accessories (GMA) - Accessory eCatalogue - Wireless Charging - Related Documents - Installation Instructions).
  - CX-30 - Go to [MSP57](#)
- No: Go to step 4.

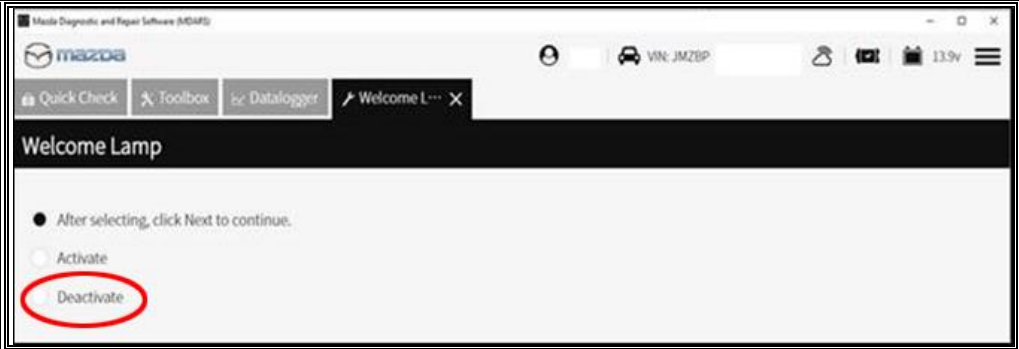
**NOTE:** If activated, the vehicle searches for the transmitter periodically after the doors are locked causing excessive parasitic draw.

5. Deactivate the Welcome Lamp.
