SPYDER 2020 RT LinQ Rack Hard To Turn - 137879

LinQ rack knob might be too hard to turn for 219400973.

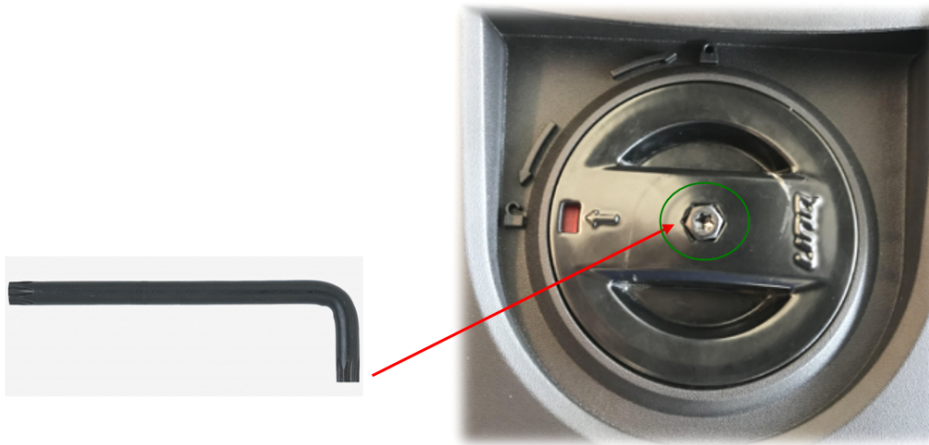
During installation, LinQ knob is impossible or very difficult to turn (Lock/Unlock).

- You can use a Torx T25 L-key to Lock/Unlock P/N 529000082

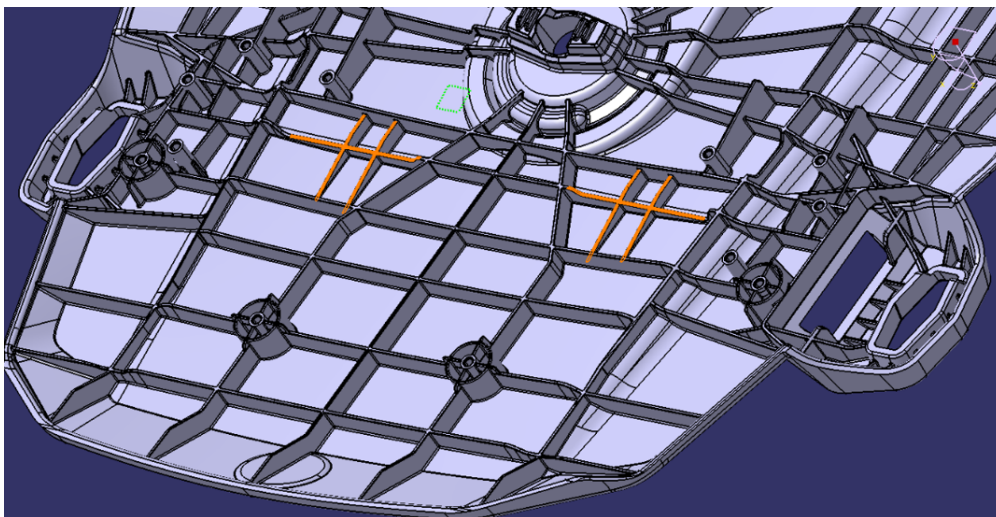
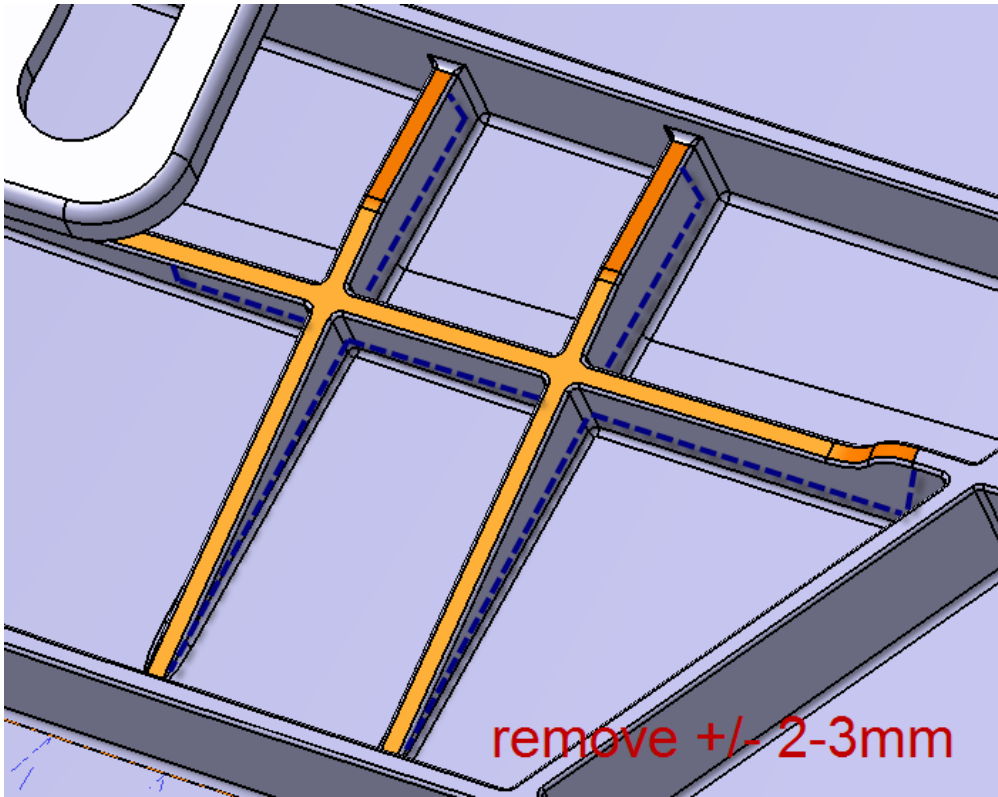
If the knob still doesn't turn or it's very hard to finalize the rotation by hand

- Grinding a portion of specific ribs as shown below;
