WLA9 - Checking Front Lid Hinges and Replacing Them if Necessary (Workshop Campaign)

Model Line: **Cayenne (9YA)**

Model Year: **2019**

Subject: **Front lid hinges**

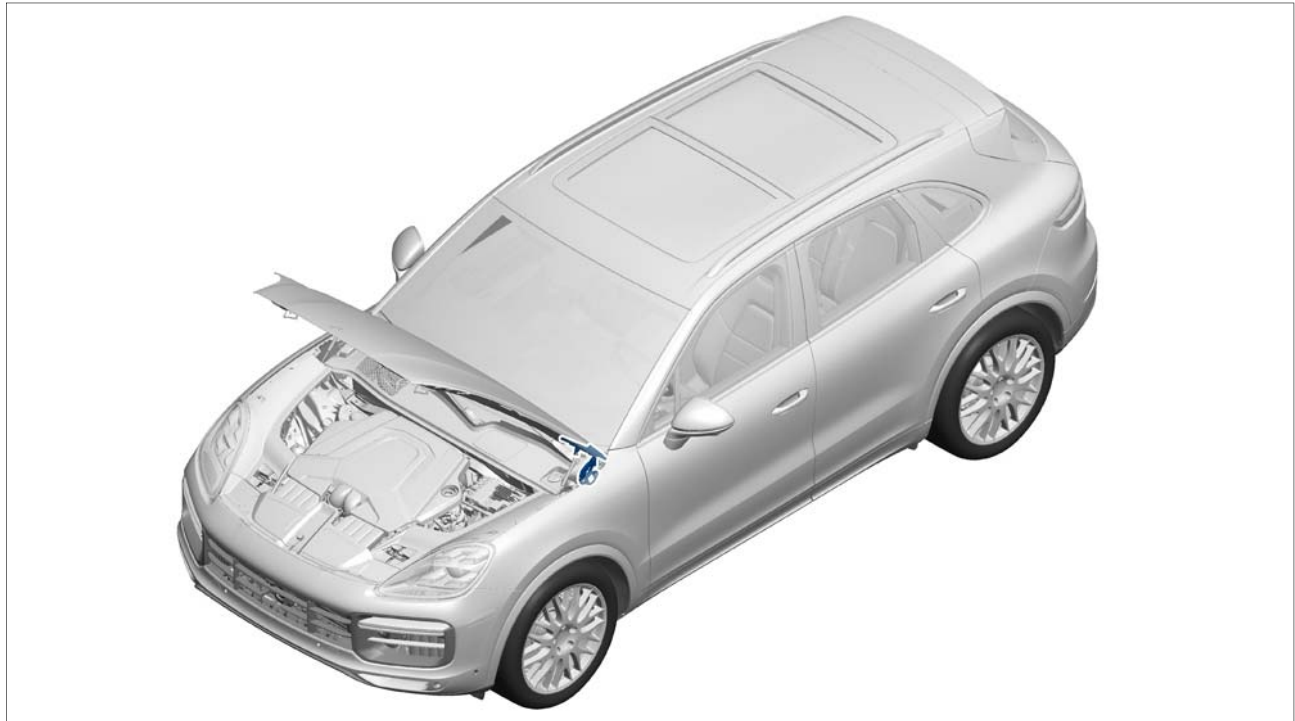
Information: **Lid hinges that may be cracked due to the use of an incorrect tool were installed on the engine compartment lid on the affected vehicles.**

*Installation position of front lid hinge***Parts required**

Remedial Action: Check front lid hinge at the left and right on the engine compartment lid and replace them if necessary.

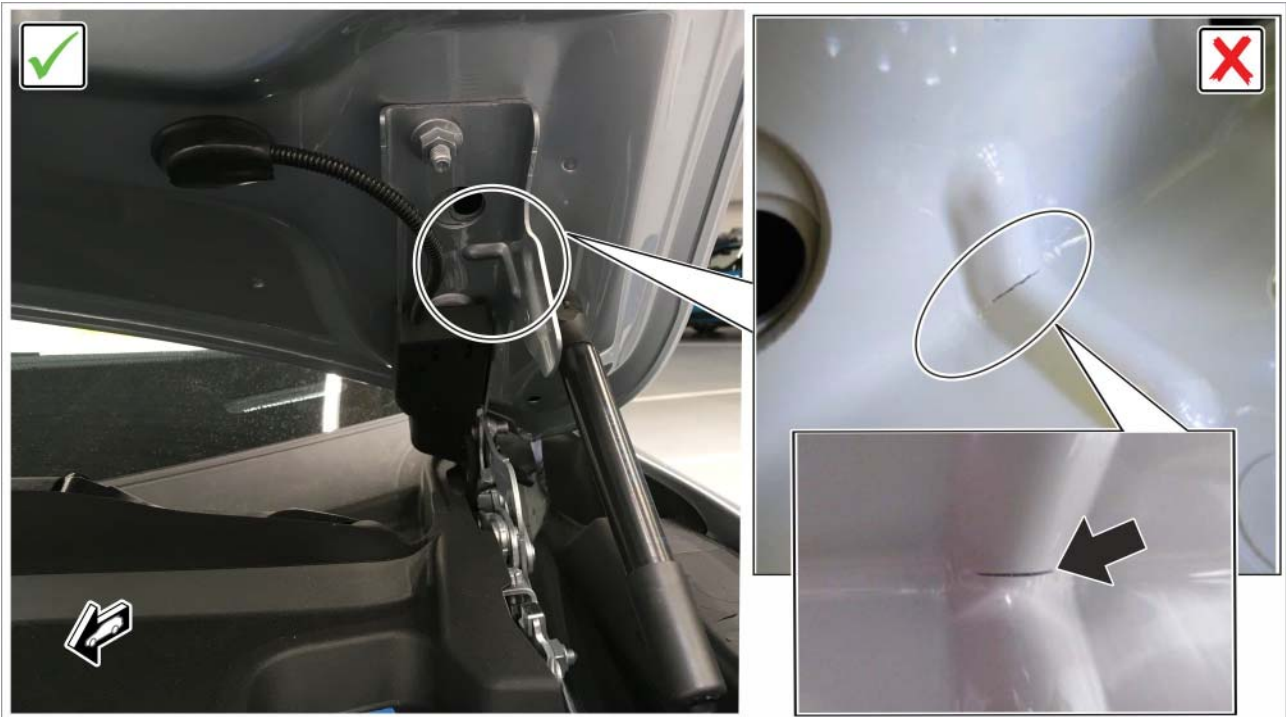
Checking lid hinges

- 2 **Illuminate lid hinges** on the engine compartment lid at the left and right using a hand lamp and **check for visible cracks in the marked area** ⇒ *Checking lid hinges -Arrow-*.

Assessment		Action required
(✓)	No cracks visible.	End of action required. ⇒ Continue with Step 4 [Invoicing: Scope 1]
(X)	Clear cracks visible in the metal.	Replace defective lid hinge. ⇒ Continue with Step 3 [Invoicing: Scope 2-13]

3 Replace front lid hinge.

For instructions, see ⇒ *Workshop Manual '552519 Removing and installing front lid hinge'* and ⇒ *Workshop Manual '552555 Replacing front lid hinge'*.

Paint the lid hinge according to instructions for new part painting stage 1 in the "Paint Manual" (see PCSS information system ⇒ Information media 'Paint Manual').
