**95B Instrument Cluster Pointers Flutter at Startup**

Models	Model Year	Model Type	VIN Range	Vehicle-Specific Equipment
Macan II	2019 - 2020	95B	N/A	N/A

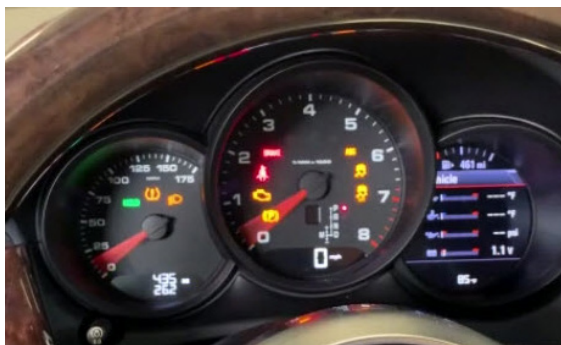
Figure 1

On startup, after the typical instrument cluster self-test, the tachometer and speedometer pointers flutter or bounce and the led indicator lamps all light up (as shown in figure 1). After a few seconds, behavior returns to normal for the rest of the drive cycle. The issue occurs intermittently.

Porsche will release information and a permanent solution to this issue in the near future. In the meantime, **do not replace any parts**. Part replacement is not an effective repair.
