Complaint - B-Pillar Trim Panel (Lower Part) Sticking Up: Reworking Main Wire Harness in Passenger Compartment (110/20)

Model Line: **Taycan (Y1A)**

Model Year: **2020**

Subject: **B-pillar trim panel (lower part)**

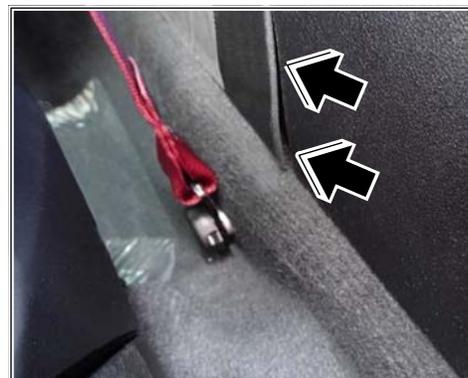
Lower part of B-pillar trim panel

Information: The main wire harness in the passenger compartment is not secured and as a result, it can press against the lower part of the B-pillar trim panel and loosen it ⇒ *Lower part of B-pillar trim panel.*

Remedial Action: Secure main wire harness in passenger compartment at the left and right using tie-wraps.
