Complaint - Wrinkling on Seat Surface / Side Bolster of Front Seat: Replacing Cover and Padding (119/20)

Model Line: **Cayenne (9YA/9YB)**

Model Year: **As of 2018 up to 2020**

Subject: **Front seat**

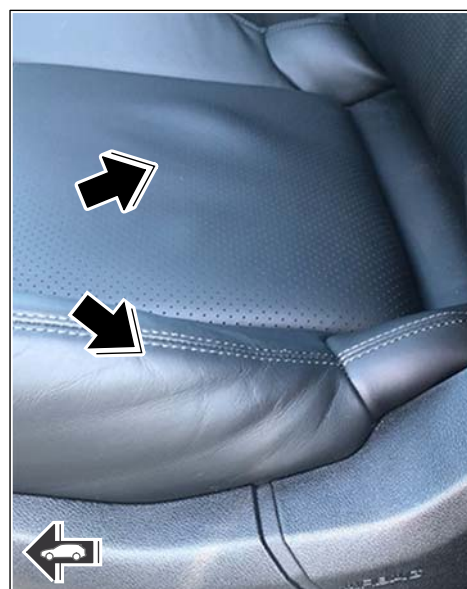
Information: Leather stretching and compression in conjunction with an entry height typical for SUVs will result in permanent wrinkles in the seat cover and side bolster ⇒ *Wrinkling on front seat -Arrows-*.

Wrinkling on front seat

Replace the relevant padding and seat cover; see
⇒ *Workshop Manual '741055 Replacing padding for front seat'*
⇒ *Workshop Manual '741319 Removing and installing cover for front seat'*.
