MODEL
**2019-2021
Multiple Models
with IVT**

NUMBER
200 (Rev 3, 08/14/2020)

TECHNICAL SERVICE BULLETIN

**SERVICE ACTION: IVT SOFTWARE LOGIC
IMPROVEMENT AND/OR IVT REPLACEMENT (SA424)**

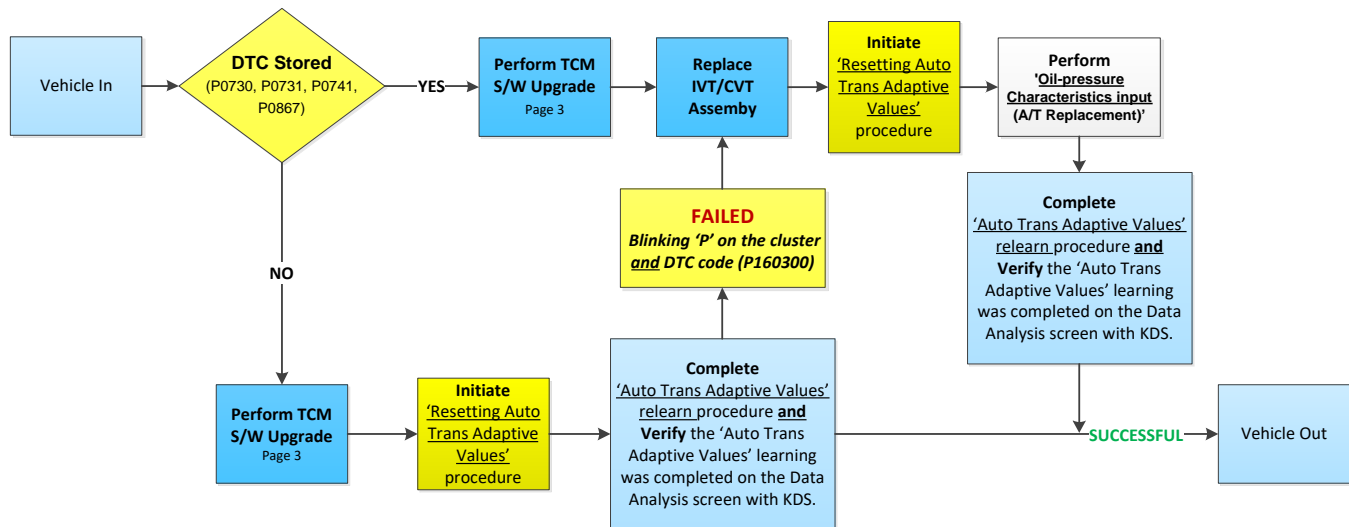
Flowchart:

**Vehicle In DTC(s):**

- P0730 – Incorrect Gear Ratio
- P0731 – Gear 1 Incorrect Ratio
- P0741 – Torque Converter Clutch Circuit Performance or Stuck Off
- P0867 – Transmission fluid pressure

After completing 'Resetting Auto Trans Adaptive Values' on the KDS:

- P160300 – P-Learning Fail (CVT System)

When replacing the IVT/CVT assembly, carefully follow the installation procedure outlined on KGIS to complete the Auto Trans Adaptive Values learning procedure. Performing the 'Oil-pressure Characteristics Input', refer to the IMPORTANT and NOTICE boxes on page 10. The adaptive values learning procedure may require that the engine be shut OFF/ON multiple times until the values are fully learned; start the vehicle, confirm the vehicle is idling in 'Park' without accelerator or brake input and verify the 'CVT Learning – P Range' Current Data reads 'ON'.

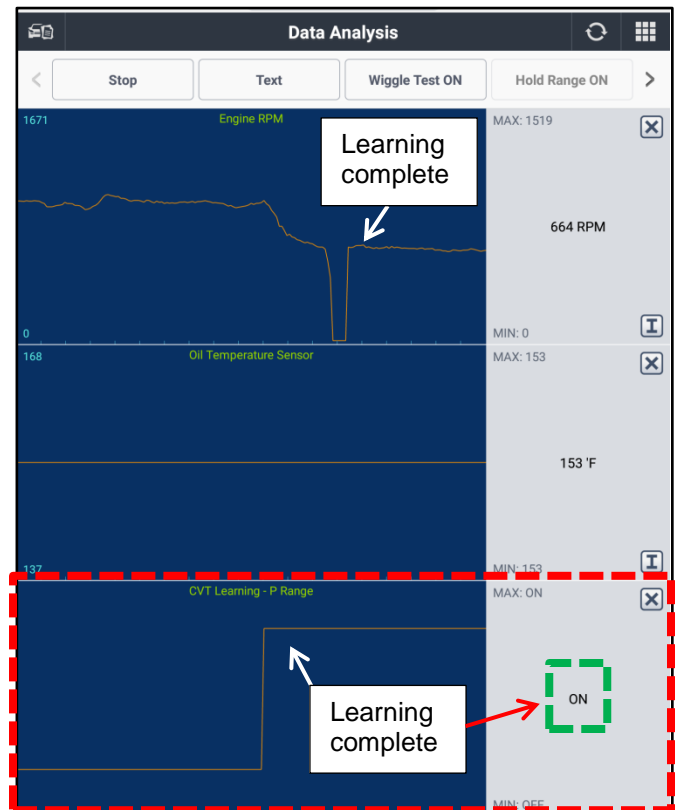
16. Start the engine to confirm proper operation of the vehicle.
17. If MIL with DTC P160300 is present **after** verifying and completing the '**Resetting Auto Trans Adaptive Values**' procedure, then proceed to replace the IVT outlined on page 10.

15. On the KDS home menu, enter the CVT module 'Data Analysis' screen and **verify** the 'Auto Trans Adaptive Values' learning was completed on the Data Analysis screen with KDS.

Note: The adaptive values learning procedure may require that the engine be shut OFF/ON multiple times until the values are fully learned; start the vehicle, confirm the vehicle is idling in 'Park' without accelerator or brake input and verify the 'CVT Learning - P Range' Current Data reads 'ON'.
