MODEL
2016-2020MY
Sorento (UMa)

NUMBER
205

TECHNICAL SERVICE BULLETIN

REAR VIEW CAMERA REPLACEMENT

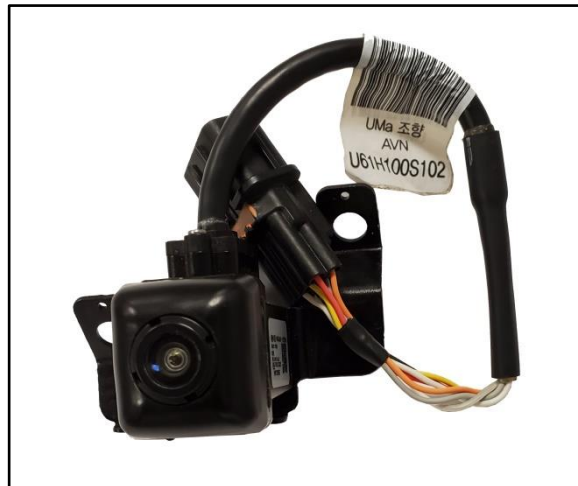
Back View Camera Assembly

This bulletin provides the procedure to replace the rear view camera on some 2016-2020MY Sorento (UMa) produced from SOP through July 9, 2020, due to distortion and/or blue screen caused by moisture intrusion into the camera assembly. The replacement camera part numbers listed in the part table have been improved to more effectively seal the camera to prevent moisture ingress in the camera assembly and improve the customer concern. Follow the procedure in this bulletin to repair the vehicle.

1. Save customer radio presets.
2. Remove and replace the back view camera by referring to the “Body Electrical System → Back View Camera System → Repair procedures” chapter in the applicable Shop Manual on KGIS.

3. Confirm normal back view camera operation.
4. Restore radio presets.
