GROUP ELE	MODEL 2021MY K5 (DL3a)
NUMBER 206	DATE August 2020

TECHNICAL SERVICE BULLETIN

**SUBJECT: SERVICE ACTION: AVN 5-WIDE NAVIGATION
MAP PACKAGE SOFTWARE UPDATE (SA433)**

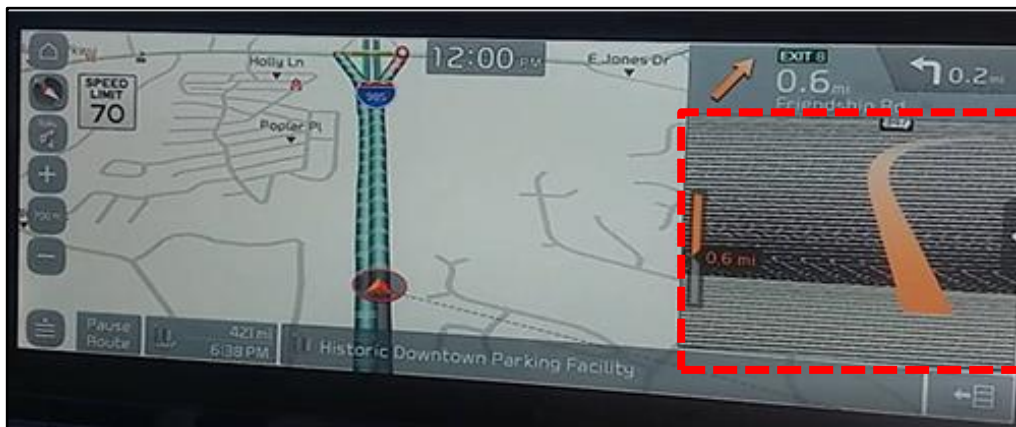
This bulletin provides information to inspect and if necessary update the navigation software on some 2021 K5 (DL3a) vehicles produced from March 27, 2020 through August 3, 2020, equipped with AVN 5-Wide head units, which may exhibit a distorted image display when navigation goes into the split screen mode (displaying upcoming change in route to a set destination) due to corrupted software file(s). Before conducting the procedure, verify the vehicle is included in the list of affected VINs.

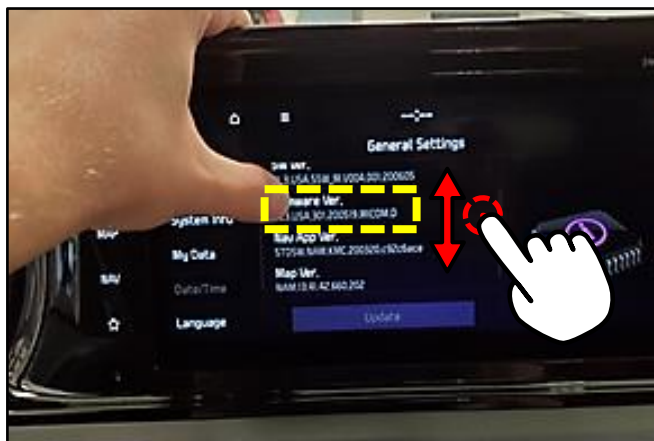
6. Using the touch screen, scroll through the 'S/W Info/Update' screen to find the "Map Ver." displayed.

If the installed head unit "Map Ver." is **NAM.13.41.42.660.202**, no further action is required. This service action is complete.

If the installed head unit "Map Ver." is **not NAM.13.41.42.660.202**, proceed to step 7.

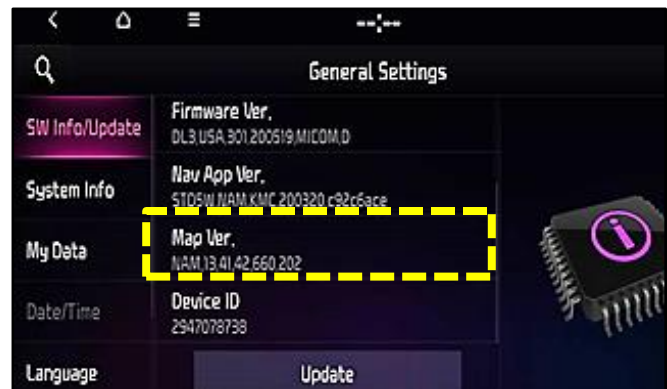
14. Repeat steps 4, 5 and 6 and confirm "Map Ver." installed is now NAM.13.41.42.660.202.

If this is not the "Map Ver." displayed, repeat the updated procedure again.
