GROUP FUE	MODEL 2019-2020MY Forte (BDm)
	NUMBER 047	DATE August 2020
TECHNICAL SERVICE BULLETIN		
SUBJECT: NU 2.0L MPI MIL ON DTC P010100 AND/OR P010600 AND/OR P006800 LOGIC IMPROVEMENT

This bulletin provides the procedure to improve the logic of the Engine Control Module (ECM) software and clean the Electronic Throttle Control (ETC) on some 2019-2020MY Forte (BDm) vehicles equipped with NU 2.0L MPI Atkinson engine, which may exhibit a MIL with DTC P0101, and/or P0106 and/or P0068. To correct this concern, apply the improved logic to the ENGINE system using the KDS ECU Upgrade function if any combination of the DTC(s) are set and clean the ETC as described in this bulletin. For confirmation that the latest reflash has been applied to a vehicle you are working on, verify the ROM ID using the table on pages 3-4 of this bulletin.

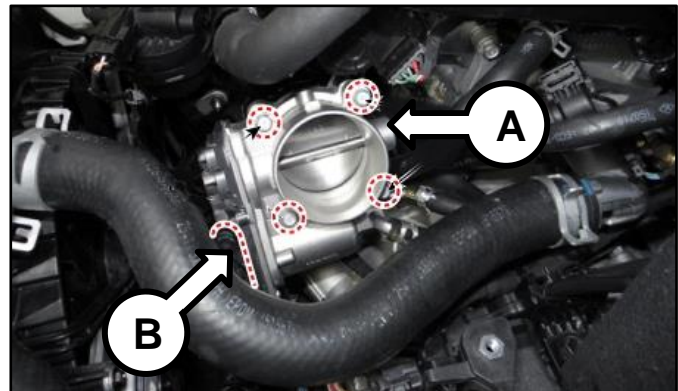
1. Remove the ETC (A) assembly by referring to the “Engine Control/Fuel System → Engine Control System → ETC (Electronic Throttle Control) System → Repair procedures” chapter in the applicable Shop Manual on KGIS.

Using a clamp tool, clamp the ETC coolant hose (B) to reduce coolant loss.

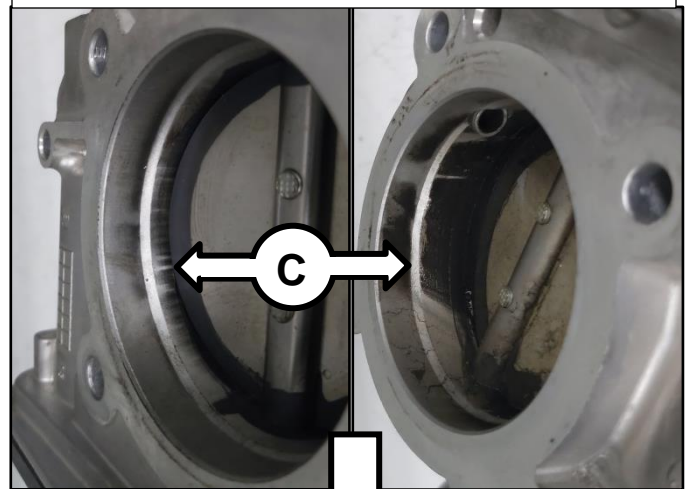
2. Using UM040 CH010 (or equivalent) cleaner, spray onto a lint free towel, then wipe the inside wall (C) of the ETC inlet to remove any carbon deposits.

The ETC throttle plate features a special coating (D) around the outside diameter of the plate. **DO NOT** use a wire brush and attempt to remove the coating.

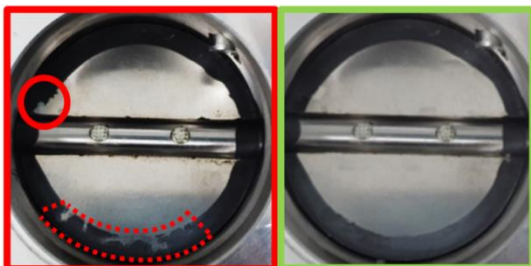
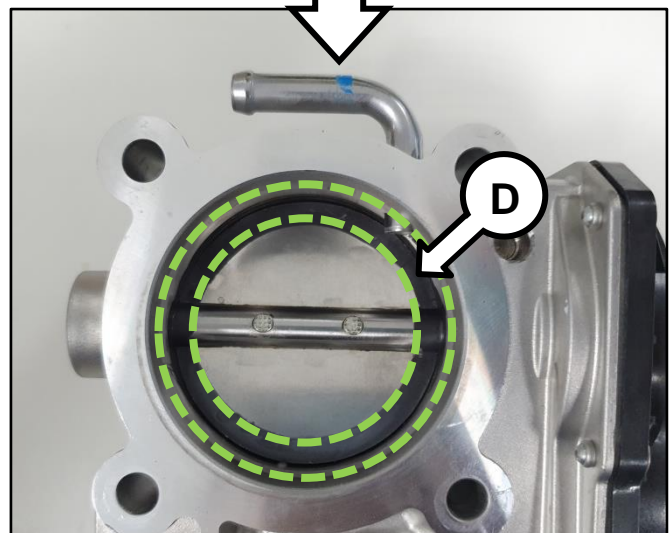
DO NOT wipe off the throttle plate coating (D), doing so (as shown below) may cause an idle performance issue.

3. Reinstall the ETC in the reverse order of removal per the Shop Manual instructions on KGIS. Note: Top off coolant as needed.
4. Verify normal vehicle operation.
