MODEL
2021MY
K5 (DL3a)

NUMBER
048

TECHNICAL SERVICE BULLETIN

**SUBJECT: SERVICE ACTION: LOW PRESSURE FUEL LINE ROUTING
INSPECTION AND/OR ADJUSTMENT (SA432)**

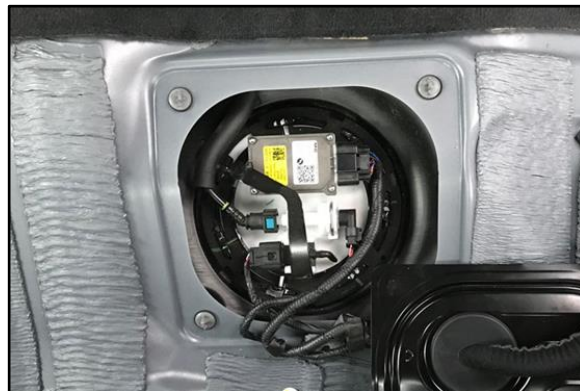
This bulletin provides information to inspect and if necessary, adjust the low pressure fuel line routing on some 2021MY K5 (DL3a) vehicles with GAMMA 1.6L T-GDI engine, produced from March 27, 2020 through July 23, 2020 which may NOT have been properly routed during assembly. The incorrectly routed fuel line may cause a Malfunction Indicator Lamp (MIL) with DTC P0087 and the vehicle may exhibit poor acceleration and/or hesitation during low speed operation. Kia is requesting the completion of this service action on all affected vehicles, including dealer stock, prior to delivery. Before conducting the procedure, verify the vehicle is included in the list of affected VINs.

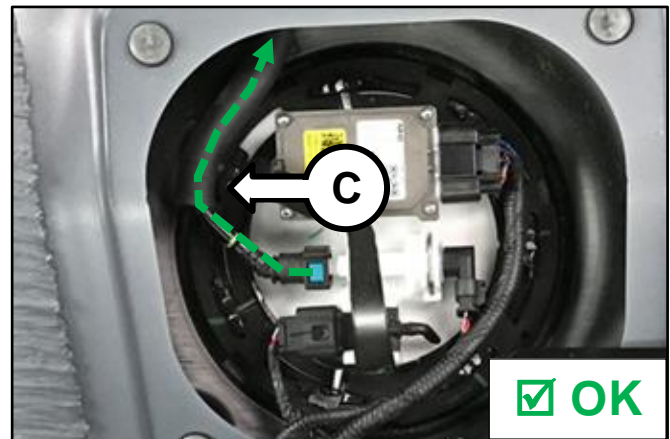
- 3a. Locate the low pressure fuel line (C) coming from the fuel pump module. The fuel line should be routed alongside the fuel pump module retaining ring and NOT crossed over the Fuel Pump Control Module (FPCM), towards the front of the vehicle.

Fuel line is routed properly (OK).

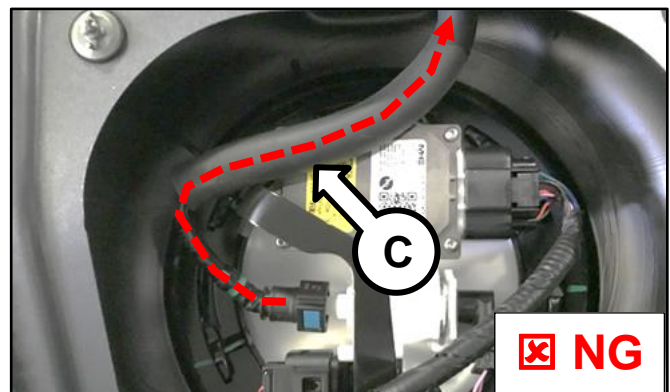
Fuel line is not routed properly No Good (NG).

- If the fuel line is not routed properly and/or a kink is found, (NG), then proceed to the 'Repair Procedure' outlined below to correct the routing of the fuel line.
- If the fuel line is routed properly and no kink is present, (OK), then this service action is complete.

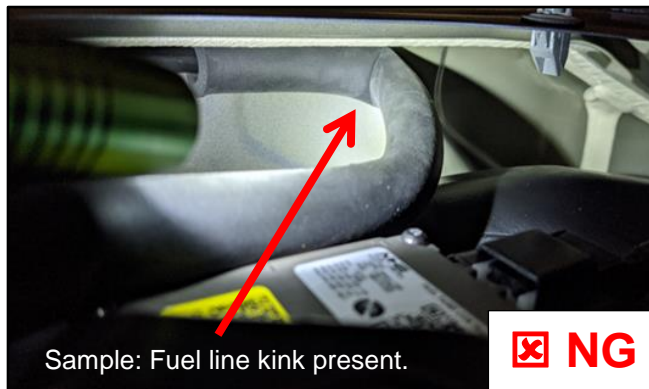
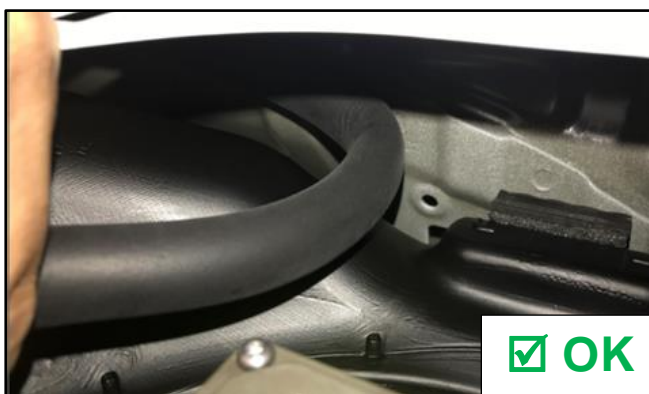
3b. Inspect the low pressure fuel line for kink(s) between the fuel tank and the floor pan.
