MODEL
2021MY
K5 (DL3A)

NUMBER
092

TECHNICAL SERVICE BULLETIN

SUBJECT: SERVICE ACTION: HOOD RELEASE CABLE, INTERCOOLER CLAMP AND WINDSHIELD SIDE MOLDING (SA431)

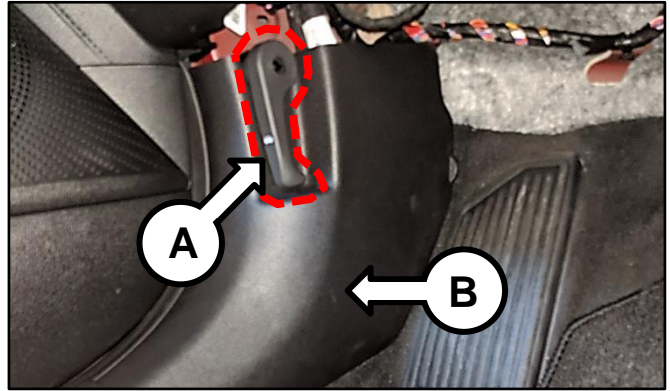
1. Pull the hood release lever (A) located on the lower left kick panel (B).

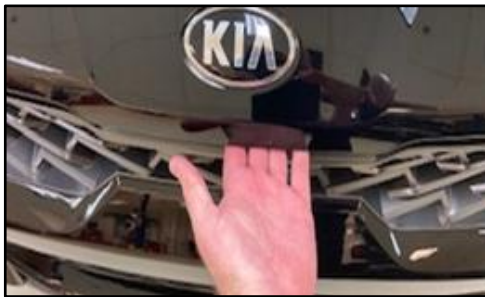
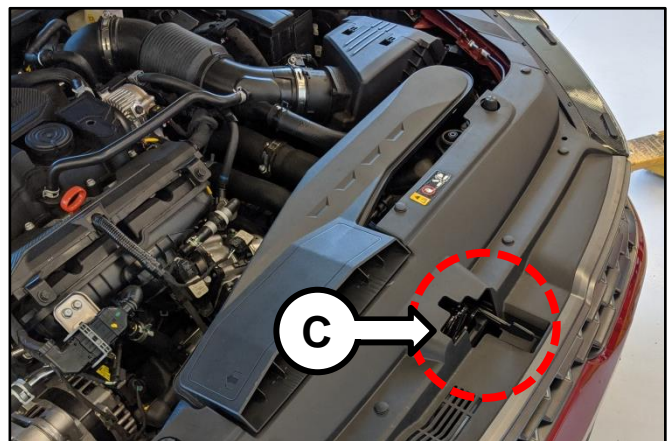
- 2a. In the front of the vehicle, locate the hood latch (C) and open the hood.

- 2b. If the hood **does not** open, proceed to step 3 to repair this concern.

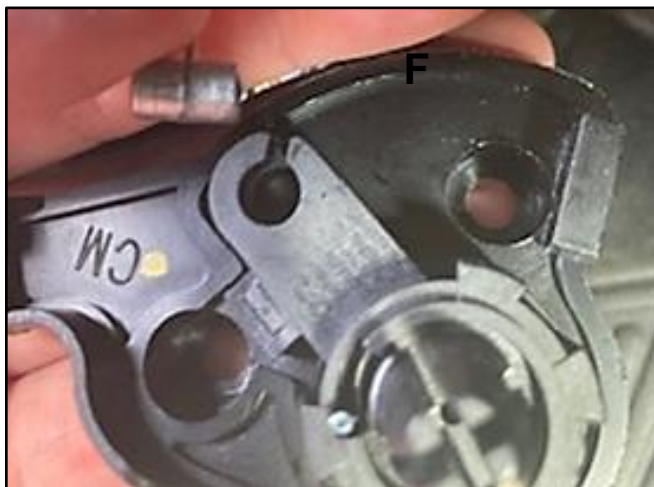
Note: Bracket has two (2) retaining bolts, refer to red outline area.

- 5a. Remove the hood release bracket (F).
- 5b. Remove the release cable (G) from the bracket (F).

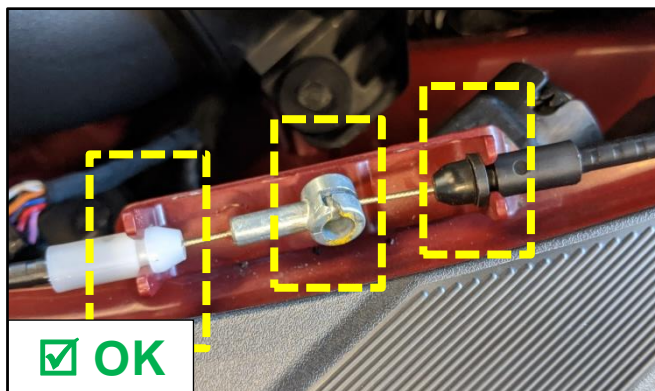
- 7a. Check the hood release cable coupler is attached properly and that the two cable attachments (black and white ends) are fully inserted into the mounting bracket(s).

Photo sample is OK.

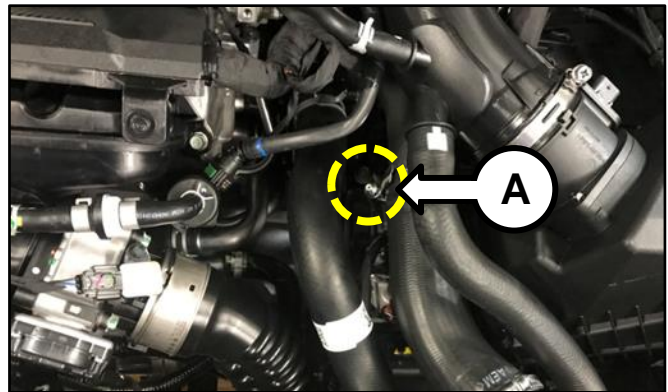
- 1. Locate the upper intercooler hose clamp (A).

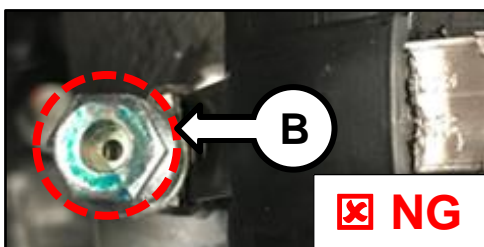
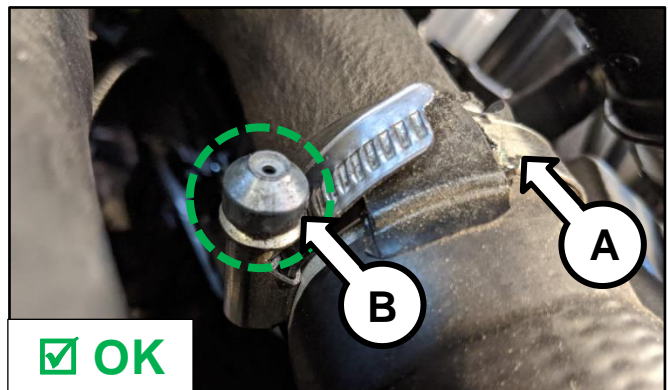
- 2a. Confirm that the hose clamp (A) break away nut head (B) is not present and that the hose is properly inserted/seated. If so, this action is complete.

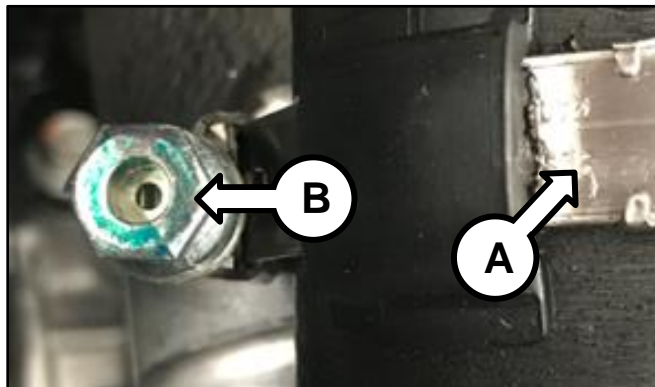
- 2b. If the hose clamp (A) break away nut head (B) is present, ensure that the hose clamp is fully inserted/seated.

If the break away nut is broken off but the hose is not properly inserted/seated then submit a normal Warranty claim to replace the clamp.

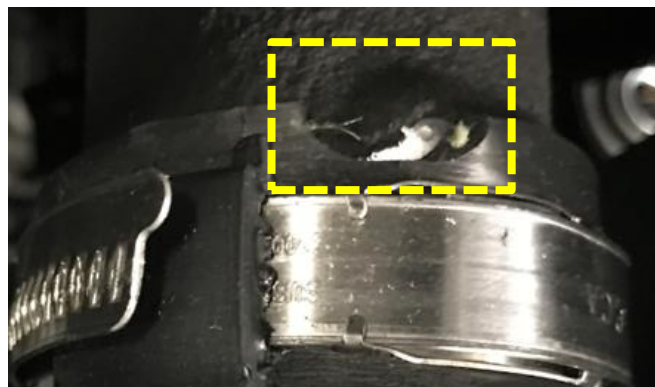
- 2c. Cut out in the hose should line up with the notch on the pipe. This confirms the coupler is fully seated.

A loose intercooler hose connection may trigger a MIL ON with DTC P017200 - System too rich (Bank 1).

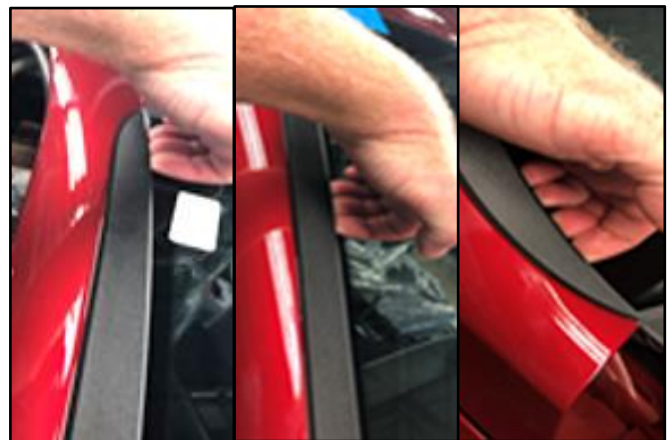
- 2a. Check if the windshield trim molding is not flush to the A-pillar or is loose. Lightly pull on the following areas shown.

- Top
- Middle
- Bottom

If any area is not flush or is loose, apply pressure in the needed area to engage retaining clip and secure.

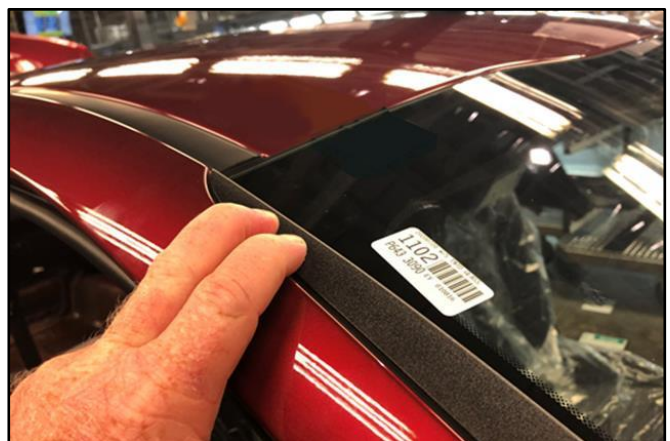
- 2b. Confirm that the windshield trim molding is flush with A-pillar and not loose. This action is now complete.

*** NOTICE**
If windshield molding clips are defective replace the windshield molding trim under normal Warranty claim.
