MODEL  
2021MY  
K5 (DL3A)

NUMBER  
092 (Rev 1, 08/12/2020)

## TECHNICAL SERVICE BULLETIN

**SUBJECT: SERVICE ACTION: HOOD RELEASE CABLE, INTERCOOLER CLAMP AND WINDSHIELD SIDE MOLDING (SA431)**

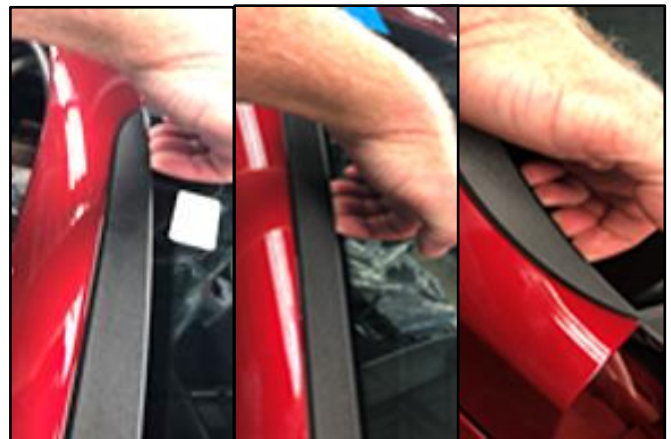
- 2a. Check if the windshield trim molding is not flush to the A-pillar or is loose. Lightly pull on the following areas shown.

If any area is not flush or is loose, apply pressure in the needed area to engage retaining clip and secure.
