Complaint - Grease Leak on Cardan Shaft Joint: Visual Inspection and Assessment (130/20)

Model Line: **Panamera (971)**

Model Year: **As of 2017**

Subject: **Rear cardan shaft**

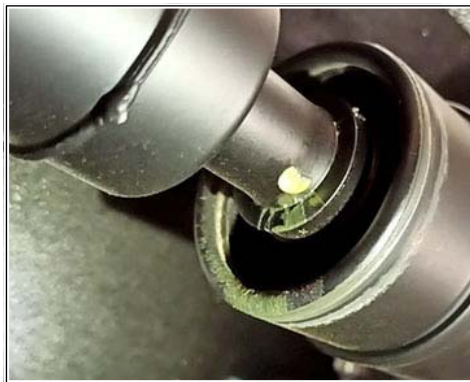
Figure 1

A small amount of grease is leaking out of the cardan shaft joint ⇒ *Figure 1* and there is a streak of grease on the heat shield ⇒ *Figure 2*.

Grease can get into the venting groove when installing the joint. Small amounts of grease leaking out will not impair the function of the cardan shaft in any way.

⇒ **Replacement of the cardan shaft is not justified.**

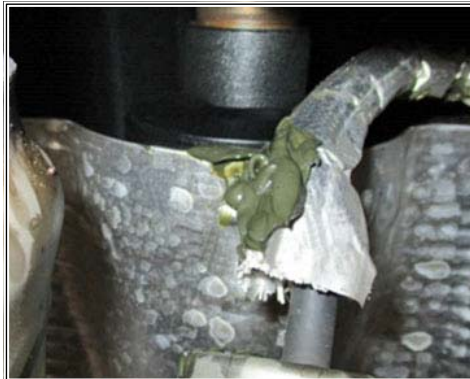
Figure 3

A large amount of grease is leaking out of the cardan shaft joint ⇒ *Figure 3* and there is a wide streak of grease on the heat shield ⇒ *Figure 4*.

Large amounts of grease leaking out will result in an imbalance while driving. In this case, the cardan shaft must be replaced.

⇒ **Replacement of the cardan shaft is justified.**
