**Symptom - Body Exterior - Reversing Camera/Reversing Camera Spray Nozzle Does Not Function: Checking Rear Wire Harness (SY 131/20)**

Model Line: **Taycan (Y1A)**

Model Year: **2020**

Subject: **Reversing camera/reversing camera spray nozzle**

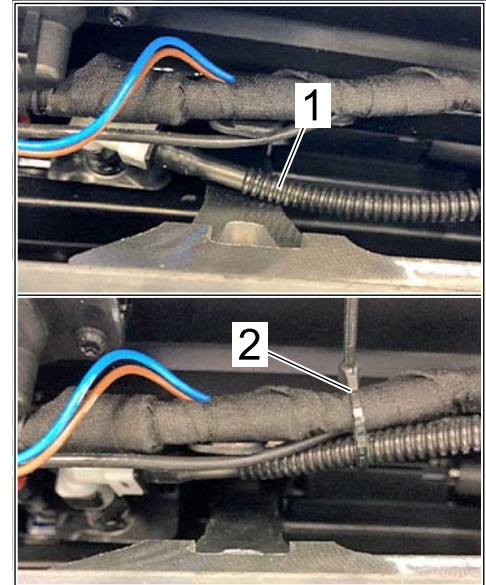
*Hose line for reversing camera spray nozzle*

Cause: The wire harness or hose line for the reversing camera spray nozzle may be touching the vehicle bodyshell and can become damaged over the service life of the vehicle.

- Work Procedure: 1 Check rear wire harness and hose line for reversing camera spray nozzle ⇒ *Hose line for reversing camera spray nozzle -1-* for damage and replace them if necessary, see ⇒ *Workshop Manual '972519 Removing and installing rear wire harness'*.
- 2 Secure hose line for reversing camera spray nozzle ⇒ *Hose line for reversing camera spray nozzle -1-* to the rear wire harness with a tie-wrap ⇒ *Hose line for reversing camera spray nozzle -2-* as shown.
