**WLA6 - Checking Rear Coil Springs and Replacing them if Necessary (Workshop Campaign)**

Model Line: **Macan (95B)**

Model Year: **2019**

Subject: **Rear coil springs**

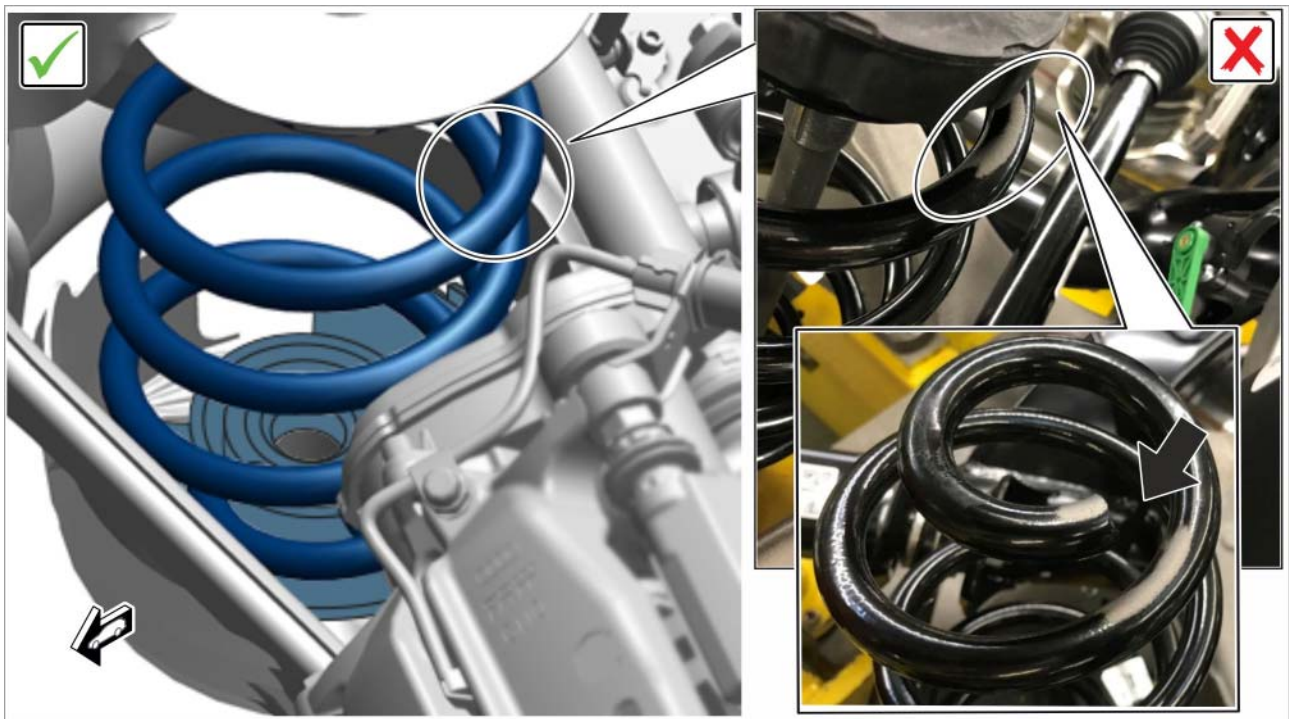
*Checking rear coil springs*

- 3 **Illuminate the surface coating** in the upper area using a flashlight and **check** whether the metallic color (silver) is **shining through** the surface coating (black).  
Assess the surface quality in accordance with the limit sample catalogue ⇒ *Checking rear coil springs*.

Assessment		Action required
(✓)	No imperfections in the surface coating. <ul style="list-style-type: none"> <li>• Metal surface (silver) is not shining through.</li> </ul>	<b>End of action required.</b> ⇒ Continue with <b>Step 5</b> [Invoicing: <b>Scope 1</b> ]
(✗)	Clear imperfections in the surface coating. <ul style="list-style-type: none"> <li>• Metal surface (silver) is clearly shining through.</li> </ul>	Replace both rear coil springs. ⇒ Continue with <b>Step 4</b> [Invoicing: <b>Scope 2</b> ]

- 4 Replace both rear coil springs ⇒ *Workshop Manual '427219 Removing and installing coil spring'*.
- 5 Install both rear wheels ⇒ *Workshop Manual '440519 Removing and installing wheel'*.
- 6 Enter the campaign in the Warranty and Maintenance booklet.
