# Product Upgrade Bulletin 200701REV

**UPGRADE BULLETIN: 200701REV**

**YEAR(S) AFFECTED:**  
2020

Sealing the front driver's side compartment to avoid water intrusion

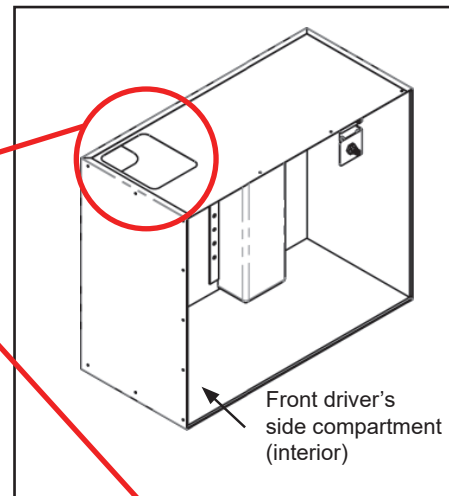
**Figure 2**

**Note: The circled area may also need thoroughly inspected and an application of foam sealant.**

5. Apply black Sikaflex 221 (polyurethane adhesive/sealant) along the exterior corner edges of the compartment. See Figures 2 and 3.
