## Diagnostic Trouble Codes (DTC) P0194-00 And/Or P016E-00, Repair - US17+OBD\* Emissions, Model Years 2018 To 2020

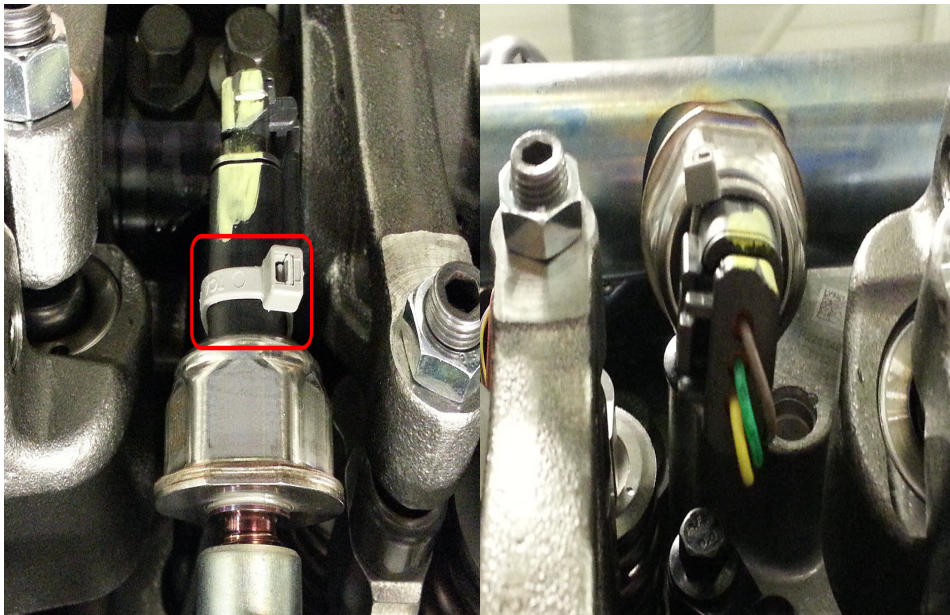
Cable tie location

Wires from the sensor connector

### 3. Secure the rail pressure sensor wire harness to the connector body with a cable tie to keep the harness away from the valve train components that move during engine operation.

- **NOTE:** Ensure that there is enough slack in the wire that there is no tension on the wires and pins at the connector when securing the cable tie.
