## Service Bulletin

**02-158**

Flush Mount Battery Box Washer Wear

8/25/2020

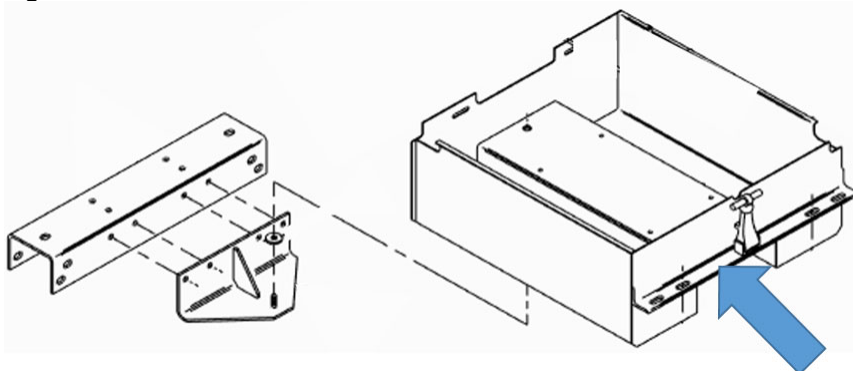
**Figure 1**

1. Determine how many reinforcement brackets are required based on the box type. Each mounting angle requires a reinforcement bracket. The example shown in Figure 1 has only one mounting angle.

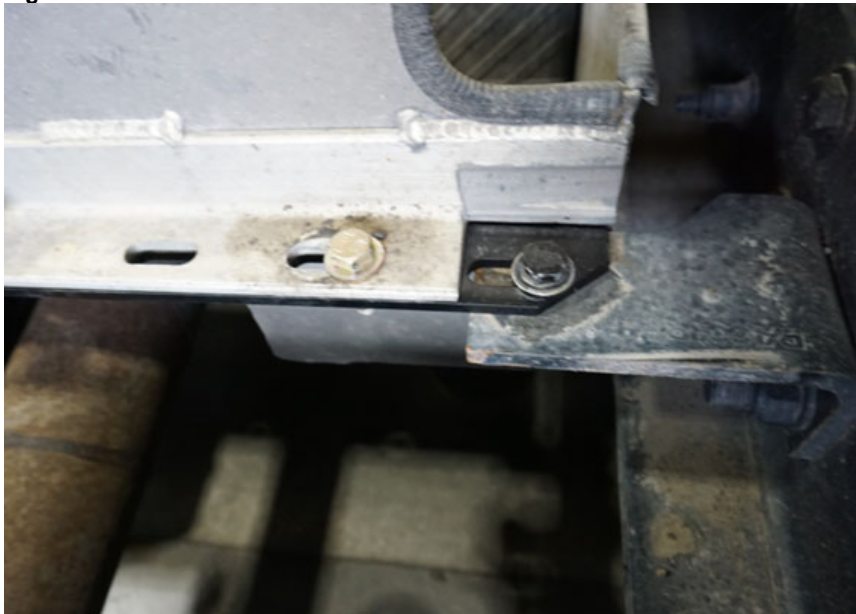
**Figure 3**

- Additional hardware may be required to secure the reinforcement bracket(s) if the battery box angles are damaged, as shown in Figure 3. The damaged corner has been removed in the image.

\* Additional hardware may be required to secure the reinforcement bracket if the corner(s) of the battery box are damaged. See Figure 3 in the Procedure section.
