## Federal Recall Information

**20PBD**

Certain Model 520 vehicles with Right-Hand Stand-Up ("RHSU") configuration may have incorrect bolts installed on the steering assist cylinder bracket. NHTSA recall number is 20V429 and Transport Canada recall number 2020-340

Subject: Safety Recall 20PBD Model 520 RHSU Steering Assist Cylinder Bracket Bolts  
NHTSA 20V429  
EXPIRATION DATE: NONE

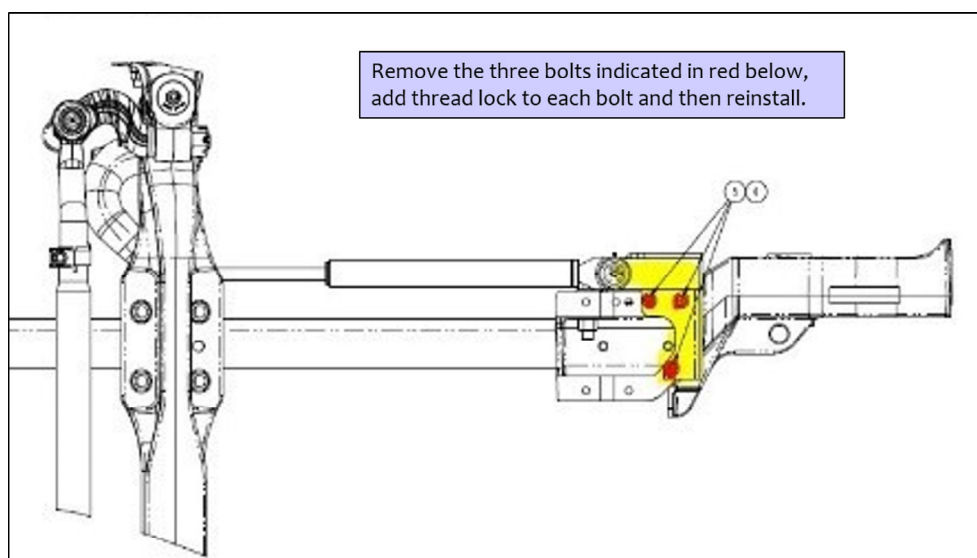
Peterbilt Motors Company has decided a defect which relates to motor vehicle safety may exist in certain Model 520 vehicles with Right-Hand Stand-Up ("RHSU") configuration built between February 15, 2019 and December 20, 2019. Vehicles may have incorrect steering assist cylinder bracket bolts installed, which prevents proper retention of these bolts. The steering assist cylinder bracket attached to the right front spring bracket with these bolts may also be damaged.

The bolts installed may not have the required thread lock and this could result in loose or missing hardware. This may cause the bracket to flex or break and cause damage to adjacent components or lock up steering.

**Review the image below for bracket and bolt location.**

1. Locate the steering assist cylinder bracket attached to the right front spring bracket.
2. Remove and reinstall the 3 bolts with Loctite 243 thread locker attaching the bracket to the front spring bracket.
3. Torque (3) M12 bolts to 75 lbft/102 Nm
