SERVICE BULLETIN

APPLICABILITY: 2019-20MY Impreza
 2019-20MY Crosstrek (Including Hybrid Model)
 2019-20MY Forester
 2019MY Legacy/ Outback
 2019-20MY WRX
 2019-20MY BRZ- Navigation -equipped ONLY
 2019-20MY Ascent

NUMBER: 15-236-18R

SUBJECT: Reprogramming File Availability for Optimization of Harman Gen 3.1 Audio and Navigation Head Units

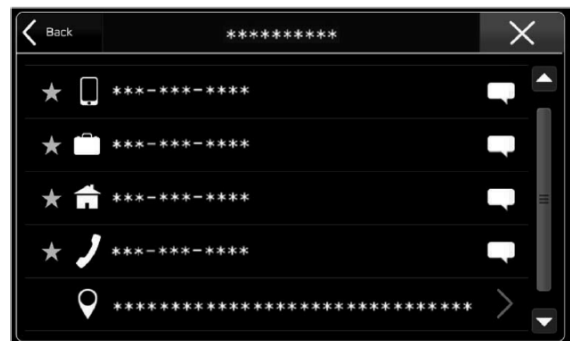
- 1) AM/FM radio station presets are lost.
- 2) Favorite Phone Contacts list is lost.
