SERVICE INFORMATION BULLETIN

APPLICABILITY: 2019MY Legacy and Outback w/ 8-in. Navi System **NUMBER:** 15-255-19R
 2019-21MY Impreza and Crosstrek w/ 8-in. Navi System **DATE:** 11-08-19
 2019-21MY Crosstrek Hybrid w/ 8-in. Navi System **REVISED:** 08/31/20
 2019-21MY Forester w/ 8-in. Navi System
 2019-21MY WRX WRX STI w/ 7-in. Navi System
 2019-21MY Ascent w/ 8-in. Navi System
 2019-21MY BRZ with 7-in. Navi System

SUBJECT: Map Data Update Procedure for Harman Gen 3.1 Navigation Equipped Head Units (H/U)

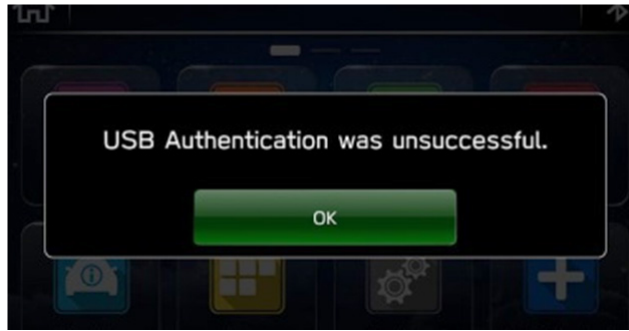
CAUTION: NEVER attempt to install this software update on any 2017 or 2018 MY vehicles as they are equipped with Gen 3.0 Navigation systems. This update is **ONLY** for models equipped with **Gen 3.1** Navigation systems. Should an attempt be made to install any of these files into a Gen 3.0 H/U, the USB Authentication error screen below will be displayed.

- The USB Authentication error screen will also be displayed when attempting to install the map data bundled with a software version older than the version already installed in the H/U.
- Move the vehicle to an outside location where the engine can be safely started and kept idling during the update process.
- Never idle the vehicle in a closed space such as a garage, even if the garage door is open.
- Once the vehicle is in a safe location, be sure the vehicle is in Park if CVT or Neutral if MT and the parking brake is fully engaged.
- Unplug any cables or available devices from the USB ports.
